SITE PLAN
Northern Battery Project

420 Northern Power Station Road
PORT PATERSON

for Davenport BESS Pty Ltd

Proposed Battery Energy Storage System

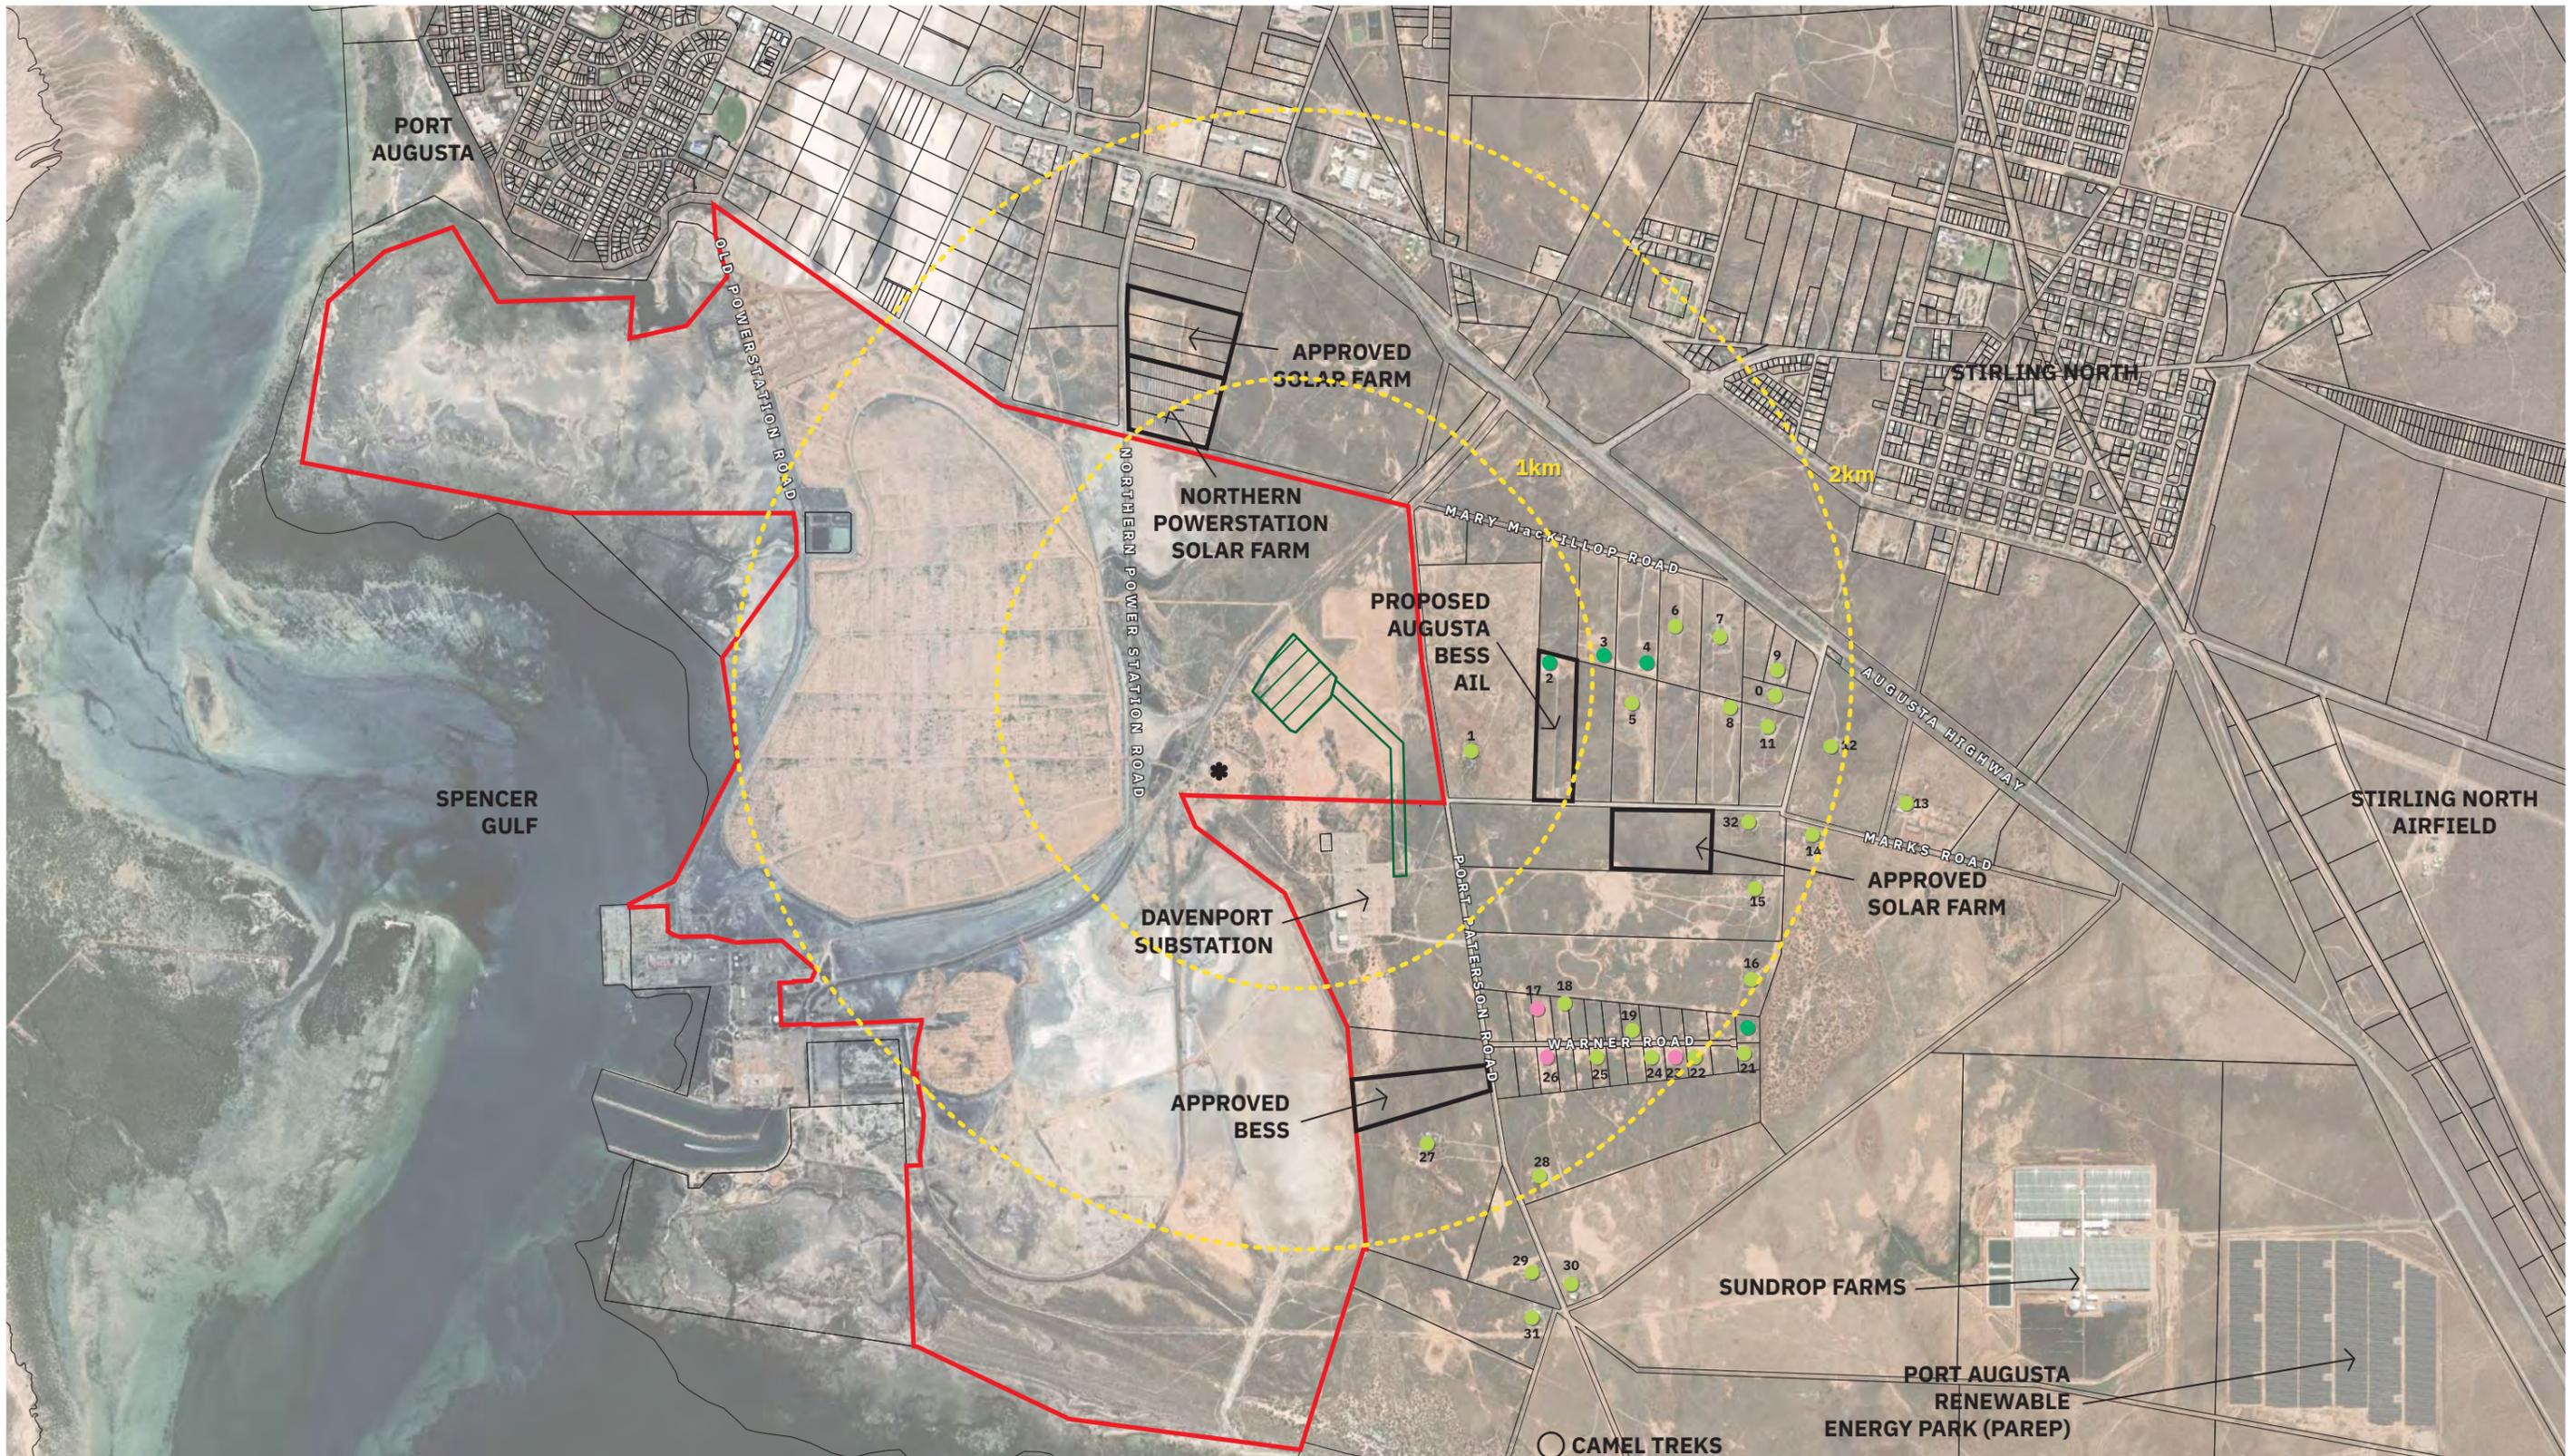
- Subject Land – Allotment 8
- Lease Area Reserve of BESS – Area Approx. 7.0ha
- Indicative underground transmission line corridor
- Davenport Substation (Electranet)
- Site Access Road

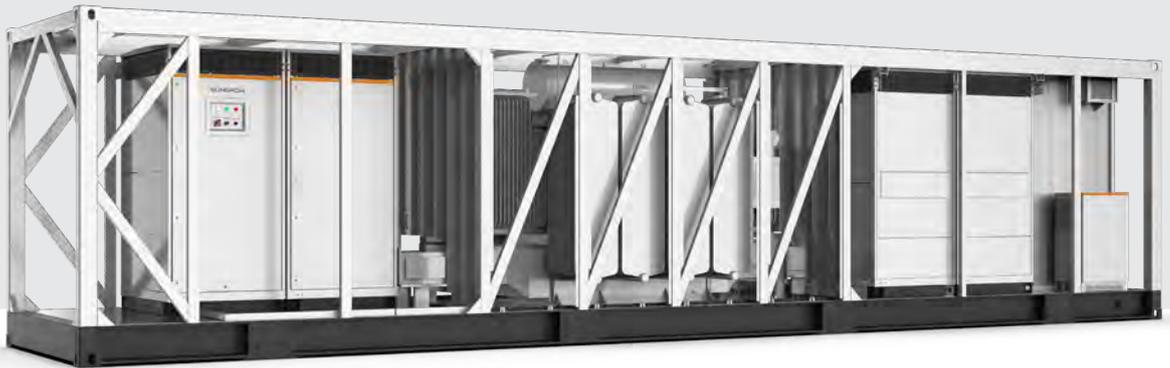
Power Conversion System

SC5500UD-MV/SC6300UD-MV/ SC6900UD-MV

- Advanced three-level technology,max. efficiency 99%
- Effective forced air cooling,no derating up to 45°C
- Wide DC voltage operation window, full power operation at 1500V

- Modular design,easy for maintenance
- IP65 protection degree, easy for outdoor installation
- C5 anti-corrosion degree, adjust to applications close to the sea

AC voltage Distortion		< 3 % (Linear load)	
DC voltage component		< 0.5 % Un (Linear balance load)	
Unbalance load Capacity		100 %	
Nominal frequency / Frequency range		50 Hz / 45 – 55 Hz, 60 Hz / 55 – 65 Hz	
Efficiency			
Converter max. efficiency		99%	
Transformer			
Transformer rated power	5500 kVA	6300 kVA	6900 kVA
Transformer max. power	6050 kVA	6930 kVA	7590 kVA
LV / MV voltage	0.55 kV / 20 – 35 kV	0.63 kV / 20 – 35 kV	0.69 kV / 20 – 35 kV
Transformer vector		Dy11y11	
Transformer cooling type		ONAN	
Oil type		Mineral oil(PCB free) or degradable oil on request	
Protection			
DC input protection		Load break switch + fuse	
Converter output protection		Circuit breaker	
AC output protection		Circuit breaker	
Surge protection		DC Type II / AC Type II	
Grid monitoring / Ground fault monitoring		Yes / Yes	
Insulation monitoring		Yes	
Overheat protection		Yes	
General Data			
Dimensions (W*H*D)		12192*2896*2438 mm

Weight		29000 kg	
Degree of protection		IP54 (Converter: IP65)	
Operating ambient temperature range		-35 to 60 °C (> 45 °C derating)	
Allowable relative humidity range		0 – 100 %	
Cooling method		Temperature controlled forced air cooling	
Max. operating altitude		4000 m (> 2000 m derating)	
Display		LED, WEB HMI	
Communication		RS485, CAN, Ethernet	
Compliance		CE, IEC 62477-1, IEC 61000-6-2, IEC 61000-6-4	
Grid support		L/HVRT, FRT, active & reactive power control and power ramp rate control, Volt-var, Volt-watt, Frequency-watt

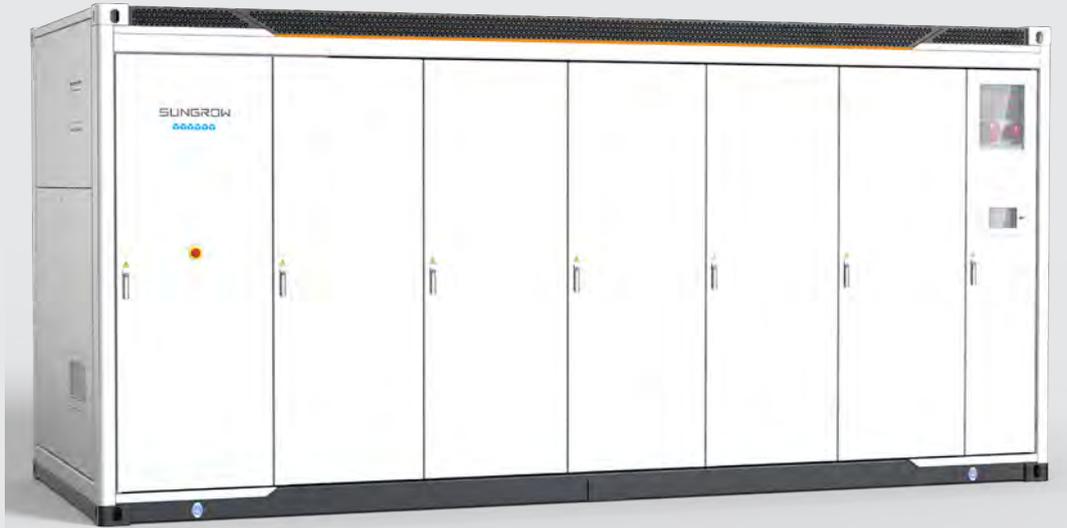
PowerTitan 2.0 Liquid Cooled Energy Storage System

- Intelligent liquid-cooled temperature control system to optimize the auxiliary power consumption
- Pre-assembled, no battery module handling on site, transportation of complete system

Product name	ST5015UX-S-2H-AU / ST5015UX-S-4H-AU
DC side	
Cell type	LFP 3.2 V / 314 Ah
Battery configuration	416S12P
Nominal capacity	5015 kWh
Nominal voltage range	1123.2 V - 1497.6 V
System parameter	
Battery container size(W * H * D)	6058 mm * 2896 mm * 2438 mm
Battery container weight	42 T
Degree of protection	IP55
Anti-corrosion degree	C4
Fire resistance time	1 h
Operation temperature range	-30 °C - 50 °C
Operation humidity range	0 % - 100 % (Non-condensing)
Highest altitude	3000 m
Temperature control method	Intelligent liquid cooling
Fire suppression system	Default: FACP, FK5112, Flammable gas detector, Smoke detector, Heat detector, Sounder beacon, Alarm bell, Extinguishant abort button, Ventilation system, Pressure relief port, Manual automatic switching and emergency starting device Optional: Sprinkler, Explosion vent panel, Aerosol
Communication interface	Ethernet
Communication protocol	Modbus TCP

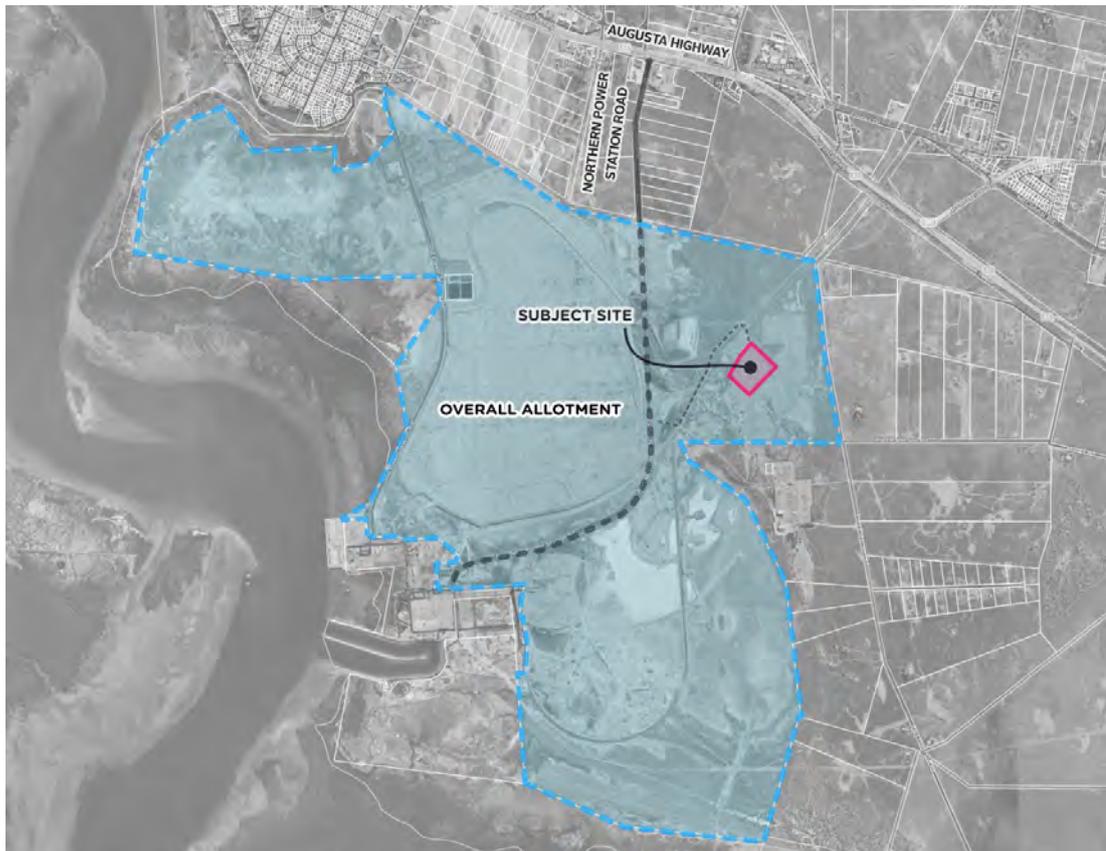
Figure 1 - Subject site, broader (overall) allotment and key adjacent roads

The subject site comprises approximately 5.7 ha area within a larger 994 ha allotment (420 Northern Power Station Road, Titel Ref: CT6226/253, Plan Parcel: D55700 A8). The site is located approximately 4.5 km south-east of Port Augusta. Figure 1 illustrates the location of the subject site with respect to the adjacent road network.

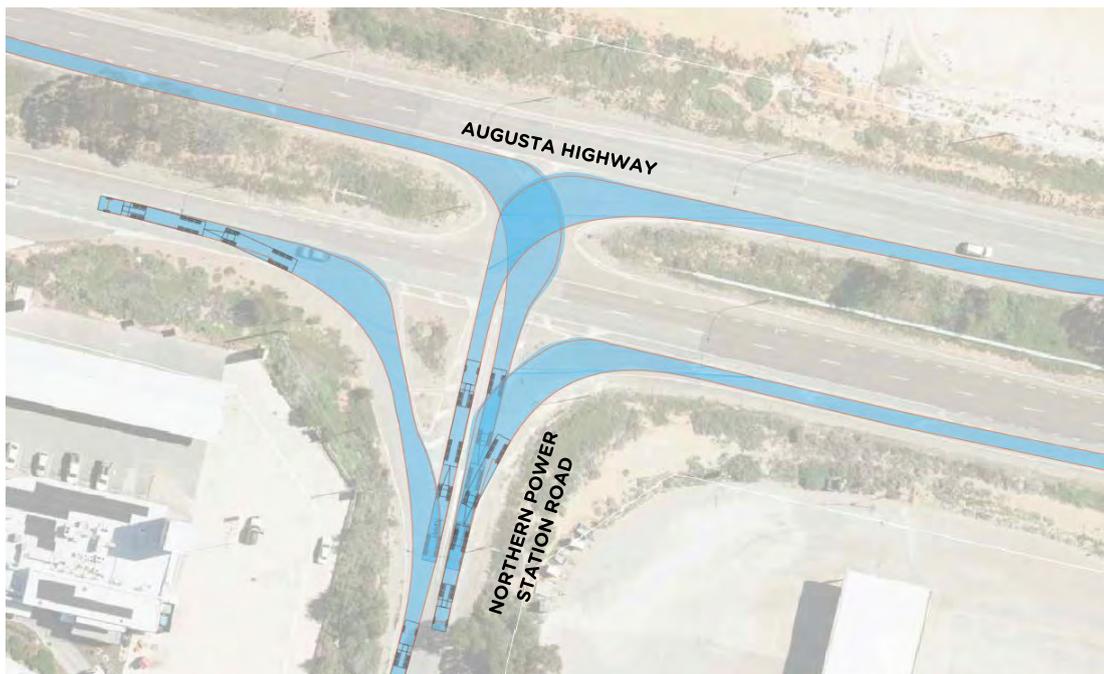
Figure 2 - PBS Level 3A Vehicle Turns at the Augusta Highway/Northern Power Station Road intersection

The Augusta Highway/Northern Power Station Road intersection treatment includes provision of separated right turn and left turn lanes on August Highway (for movements into Northern Power Station Road). The wide median opening also incorporates two-stage right out movements from Northern Power Station Road. A short acceleration lane is also provided within the median for the right-out movement.

A review of turn paths for PBS Level 3A vehicles has been undertaken for the intersection as illustrated in Figure 2. The turn paths illustrate that the movements are generally easily accommodated, albeit the left turn from Augusta Highway to Northern Power Station Road is relatively tight (the turn path suggests the vehicles need to slightly overhang the adjacent splitter island and central painted median to complete the turn within the carriageway). Nevertheless, turn path analysis is typically conservative (particularly in relation to PBS standard vehicles) and the subject movements are already gazetted and legally permitted at the intersection.

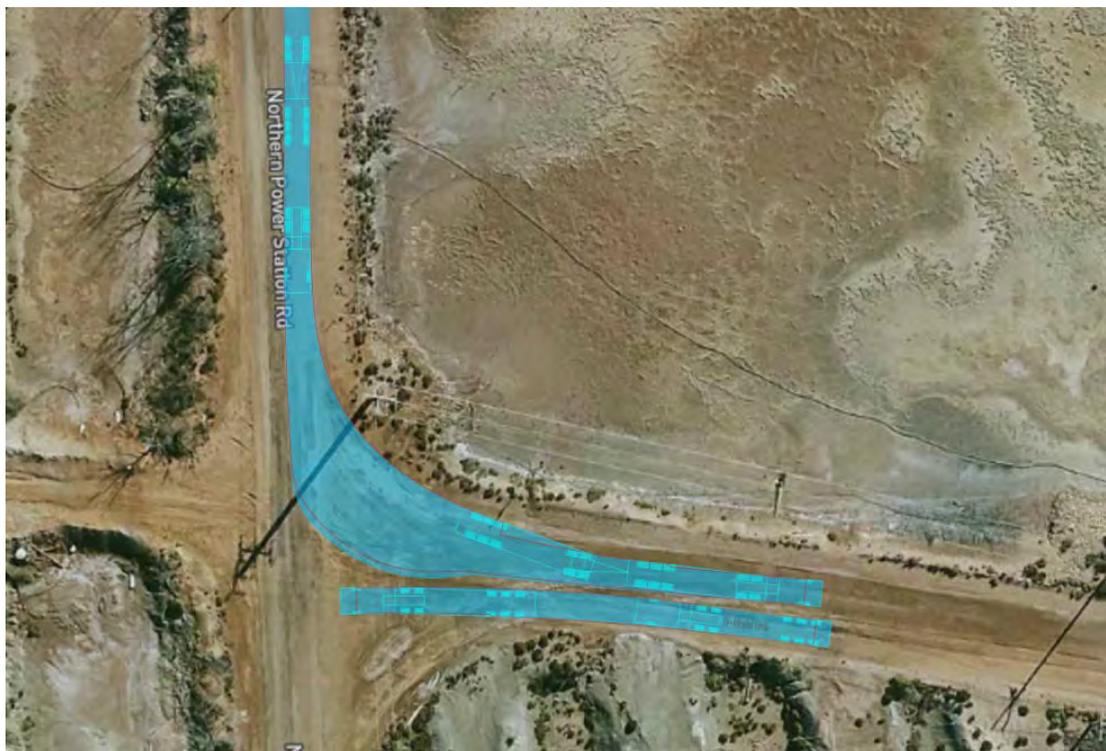
The internal 'intersection' of the proposed access track with the private section of Northern Power Station Road will adequately accommodate two-way movements of a 36.5 m Road Train (largest vehicle currently gazetted on Northern Power Station Road) entering the access track while an exiting commercial vehicle gives way as illustrated in Figure 4. OSOM vehicles (if utilised) may required a greater swept path through the intersection and, as such, appropriate traffic management measures shall be implemented if such vehicles are used.

Figure 4 - Internal 'intersection' of access track and (private section of) Northern Power Station Road

Noting the previous earthworks undertaken within the subject portion of the overall site, the new access track connection within in it should be developed with appropriate gradients to ensure safe operation of commercial vehicles during both construction and operation. Gradients should be no steeper than 1 in 6.5 with a maximum rate of grade change of 1 in 16 in 10 m of travel (as per the recommendations of AS 2890.2). These grades are based on commercial vehicles up to 19.0 m Semi-Trailers. Should larger vehicle combinations (such as RAV/OSOM vehicles) be required for access, further advice in respect to gradients should be sought.

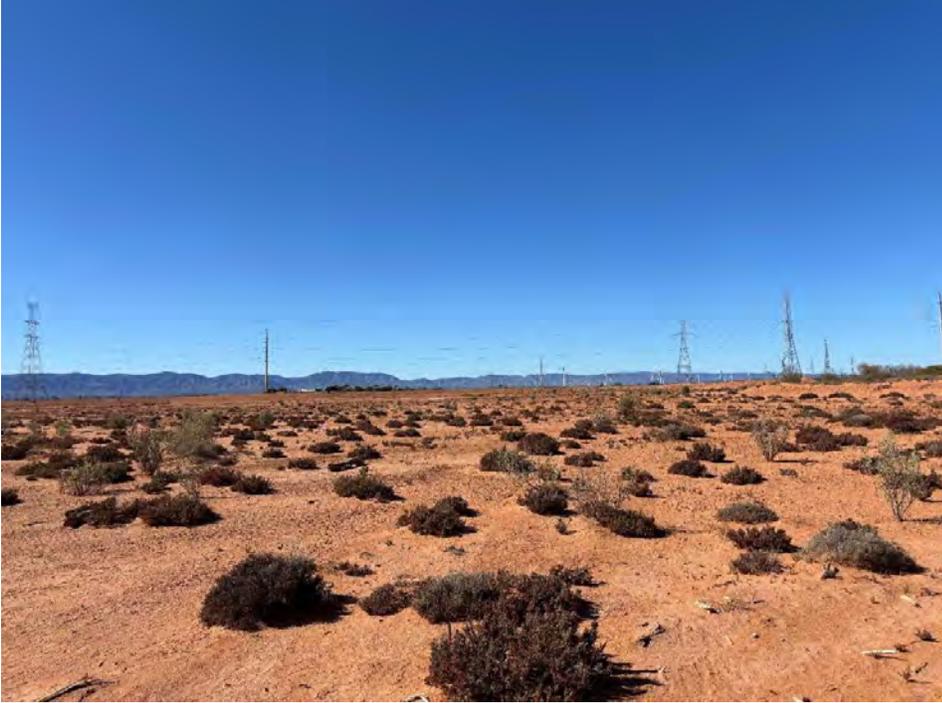
Photo 1 – Direction South East 32°31'42"S 137°48'33"E

General description	Highly disturbed site with dominant species <i>Atriplex nummularia</i> (suspect some direct seeded) and <i>Tecticornia</i> (Sapphire species) with <i>Nitraria billardierei</i> and <i>Atriplex vesicaria</i> .				
Threatened species or community	Threatened fauna under the NP&W Act - <i>Neophema elegans elegans</i> (R)				
Landscape context score	1.06	Vegetation Condition Score	16.45	Conservation significance score	1.02
Unit biodiversity Score	17.79	Area (ha)	6.7	Total biodiversity Score	119.19

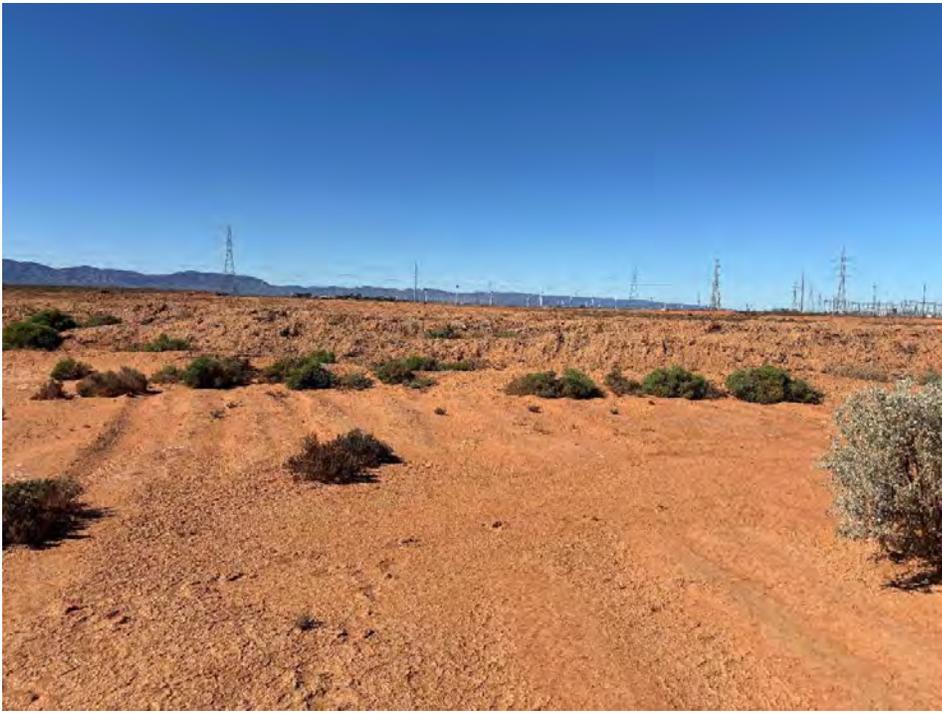
Photo 2 – Direction South East Over looking dumped soil

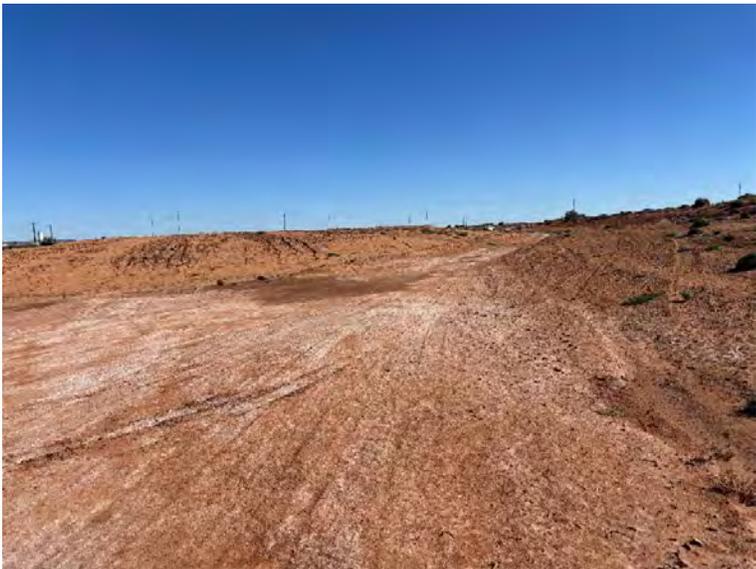
A 2 - Looking North where the transmission line will run – site has soil removed.

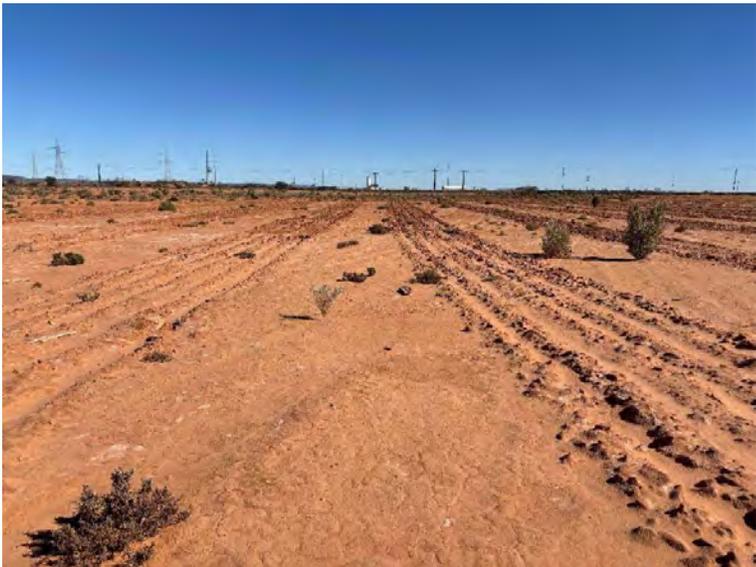
A3 – Lines indicating a revegetation attempt
Looking West

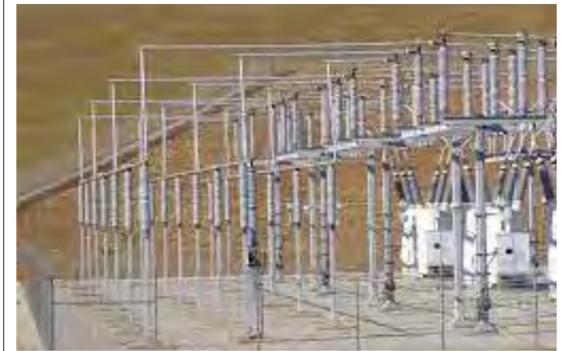
EXAMPLE BUS PIPES, 6-10m IN HEIGHT

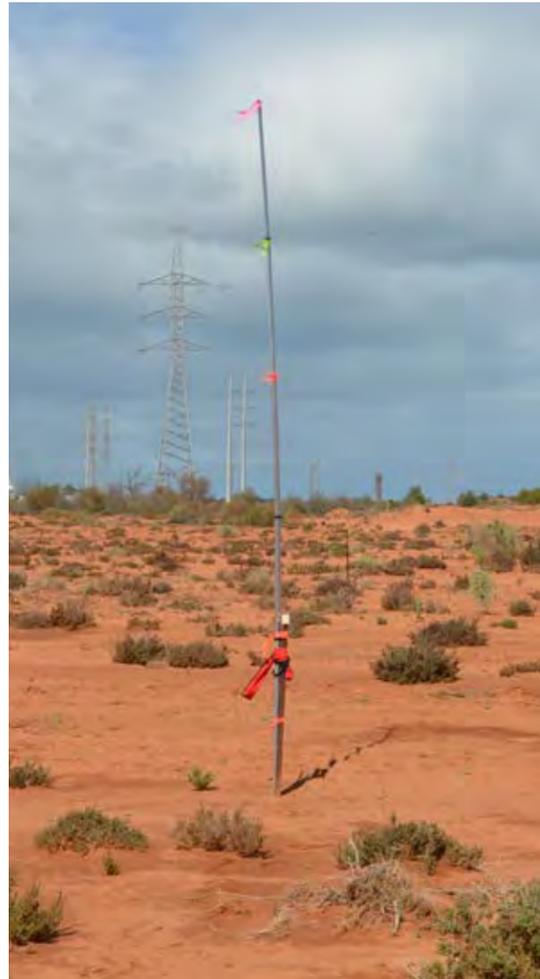
- All photos were taken on a Nikon D7000.
- Focal length was set at 22mm.
- All photos were taken at eye level, with no filter.
- Photos were taken from within the subject site and within publicly accessible locations.
- Photos were taken and viewpoint locations were geo-referenced using Google Earth.
- A 5.0m height mast was fixed to an existing star dropper within the project site to identify the project site within the local area. The location of the mast was geo-referenced using Google Earth.
- A series of locations were selected to illustrate the visual impact of proposal.

PHOTOGRAPH OF THE 5.0M HEIGHT STAFF, ON-SITE

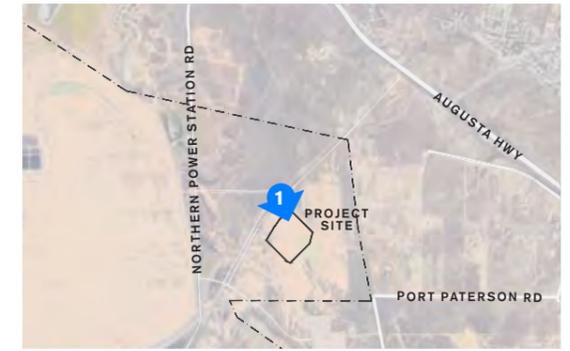
VIEWPOINT 01 - ORIGINAL

Location	Private Access Road
Distance from the site	120m
Date & time	27.08.2025 - 12:00pm
Image modifications	None
Visual notability	Moderate
Visual impact	Low

- This view is from the private access road (location of the proposed site access).
- The visual impact is assessed as low for the following reasons:
 - The viewpoint is from a private access road and is only available to staff and approved visitors. It is not available to the public.
 - The site is already heavily modified and largely devoid of vegetation, with low landscape quality and scenic value.
 - Existing views are dominated by the Davenport Substation, high-voltage transmission lines, and nearby windfarms.
 - The proposal will result in a minor scenic change.
- The inclusion of new landscaping as part of the proposal presents an opportunity to enhance the overall landscape quality of the site.

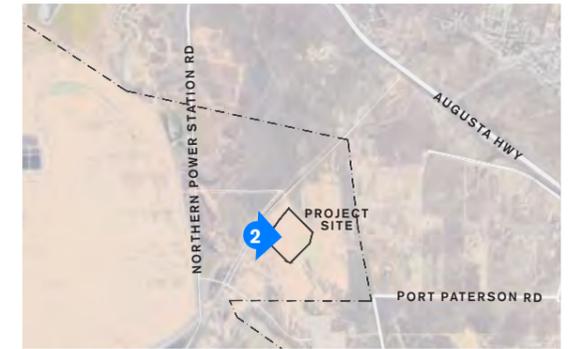
VIEWPOINT 02

Location	Private Access Road
Distance from the site	120m
Date & time	27.08.2025 - 12:00pm
Image modifications	None
Visual notability	Moderate
Visual impact	Low

- This view is from the private access road (location of the proposed site access).
- The visual impact is assessed as low for the following reasons:
 - The viewpoint is from a private access road and is only available to staff and approved visitors. It is not available to the public.
 - The site is already heavily modified and largely devoid of vegetation, with low landscape quality and scenic value.
 - Existing views are dominated by the Davenport Substation, high-voltage transmission lines, and nearby windfarms.
 - The proposal will result in a minor scenic change.
- The inclusion of new landscaping as part of the proposal presents an opportunity to enhance the overall landscape quality of the site.

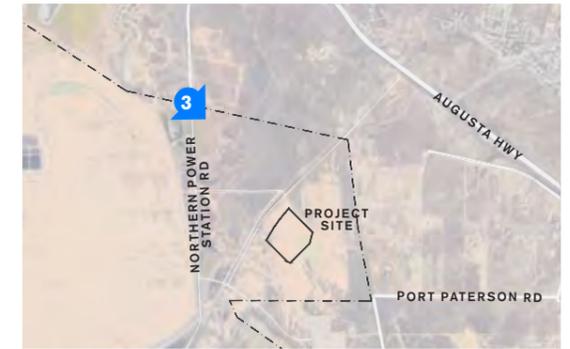
VIEWPOINT 03

Location	Northern Power Station Road
Distance from the site	1,050m
Date & time	27.08.2025 - 12:00pm
Image modifications	None
Visual notability	Negligible
Visual impact	Negligible

- This view is from Northern Power Station Road, prior to the private access gate.
- The visual impact is assessed as negligible for the following reasons:
 - The significant distance between the viewpoint and the project site.
 - The moderate scale of the proposal relative to the surrounding infrastructure.
 - The existing visual clutter caused by high-voltage transmission lines, the Davenport Substation, and the Caroona Solar Farm.
 - Northern Power Station Road functions as a service road providing access to private property, including the project site, and experiences very low levels of use.

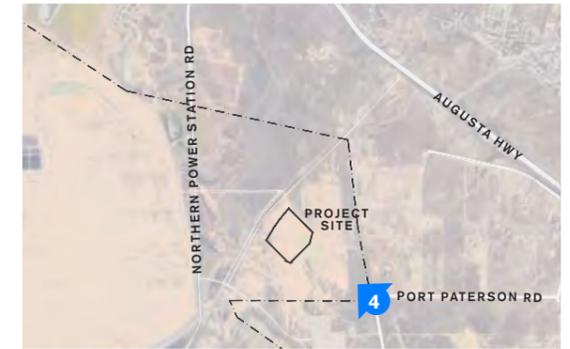
VIEWPOINT 04

Location	Port Paterson Road
Distance from the site	600m
Date & time	27.08.2025 - 12:00pm
Image modifications	None
Visual notability	Negligible
Visual impact	Negligible

- This view is from Port Paterson Road, adjacent to the dwelling at 190 Port Paterson Road.
- The visual impact is assessed as negligible for the following reasons:
 - The distance between the viewpoint and the project site.
 - The siting of the proposal within an excavated area, which results in very low visibility.
 - The presence of existing visual clutter, including high-voltage transmission lines, the Davenport Substation, and the Caroon Solar Farm.
 - Port Paterson Road provides access to approximately 20 dwellings and experiences very low traffic volumes.
- The inclusion of new landscaping as part of the proposal offers an opportunity to enhance the overall landscape quality of the site.

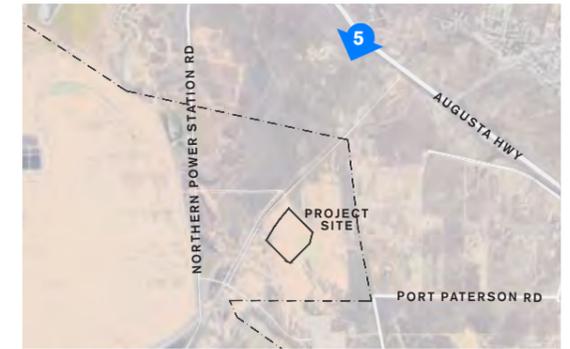
VIEWPOINT 05

Location	Princes Highway
Distance from the site	1,300m
Date & time	27.08.2025 - 12:00pm
Image modifications	None
Visual notability	Negligible
Visual impact	Negligible

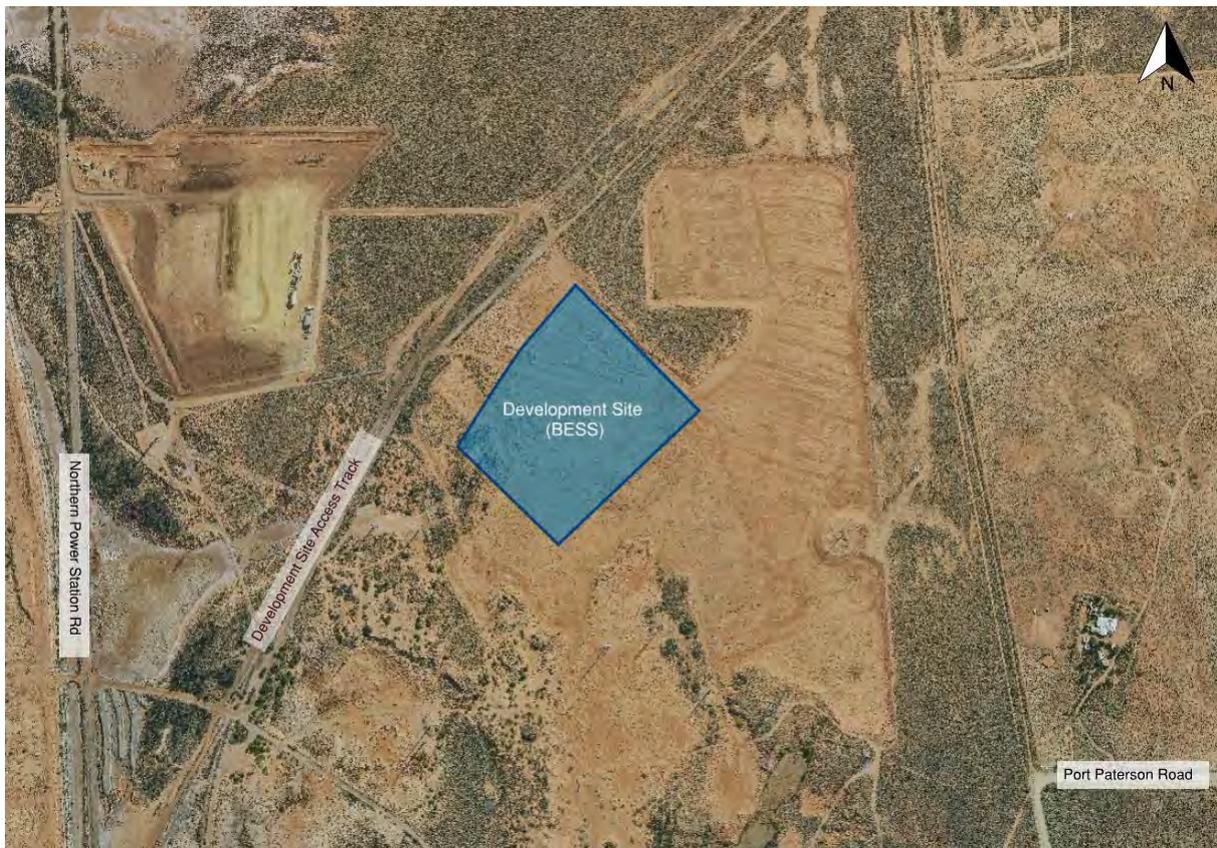
Figure 1: Locality Plan

The Development site as depicted in Figure 1 is approximately 5.4 hectares in area and is located approximately 5km southeast of Port Augusta. The site is located northwest of Port Paterson Road and east of Northern Power Station Road.

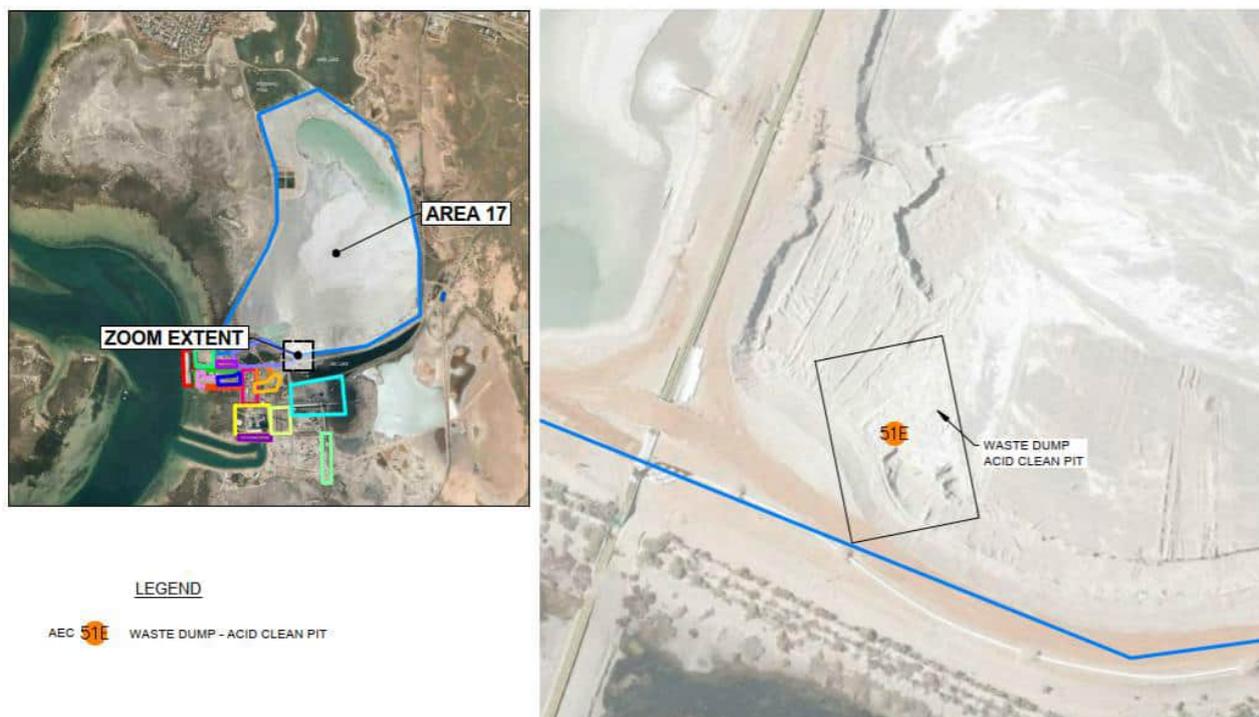
Figure 1-3. Location of the waste dump for acid – located approx. 1.5km to the south-west

- The ash storage area (ash pond) nominated at Area 17 contains material within expected chemical ranges for bottom ash and has been effectively managed through dust suppression and planned revegetation, significantly reducing the potential for airborne particulate exposure. Previous short-term dust events have been linked to surface degradation, highlighting the importance of ongoing dust control. The main potential for contamination is defined as a waste dump for acid located near the southern boundary of this area (Shown in **Figure 1-3**). The closest point for defined Area 17 is approximately 450m to the west. The waste dump is located approximately 1.5km to the south-west. Due to the distance from the proposed development area and known as down hydraulic gradient it is considered a very low likelihood to impact the development area.

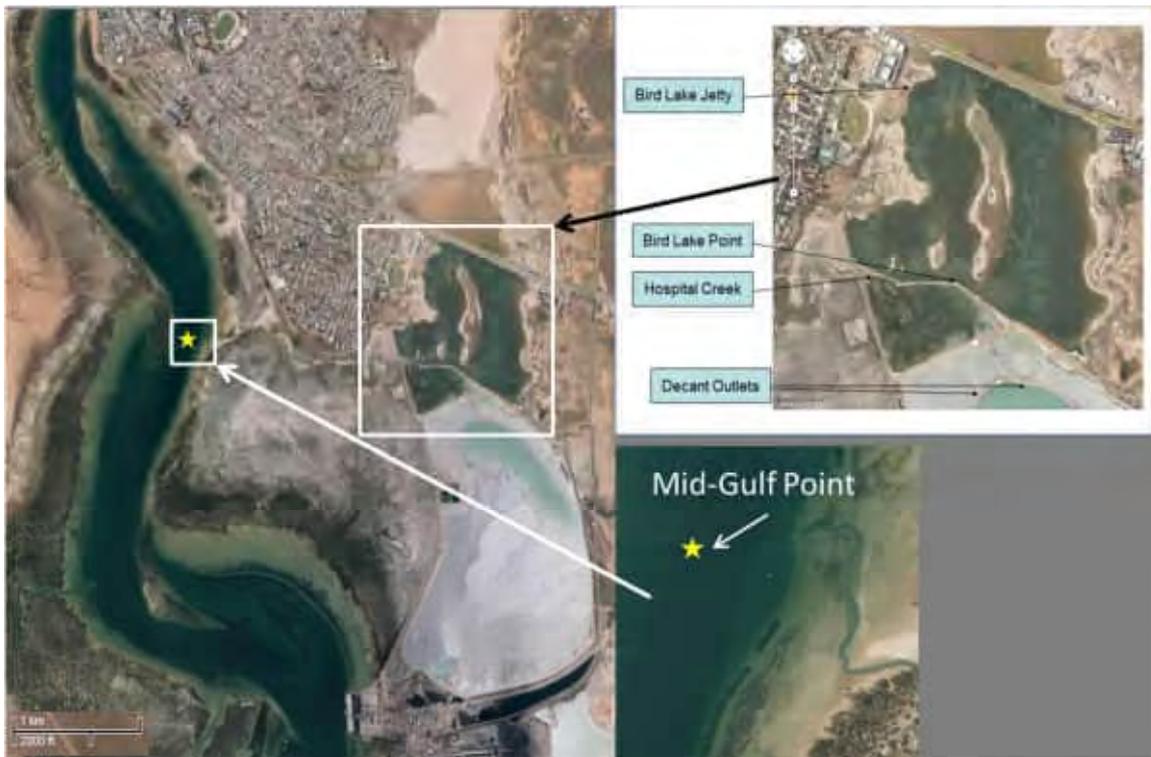
Figure 2.1: Surface water quality collection points (FPP)

Coffey has been provided with water quality data collected between May 2007 and August 2015 from Hospital Creek, Bird Lake Jetty, Mid Gulf Point and at a background location called Transect 7. Water collected at each event was tested for trace elements and nutrients, results are presented in Table 24 and locations are presented below.

In order to improve the appearance of the entrance to the township of Port Augusta it is understood that in the late 1960s ETSA diverted discharge water from the power station to create Bird Lake, an artificial lake on dry clay pans to the north of the site. Bird Lake was fed through overflow from the ash ponds on-site via the final polishing pond with a levee which was constructed in 1987. Water discharges into Spencer Gulf via Hospital Creek which is a mainly natural tidally influenced creek system (see Figure 2.1 below).

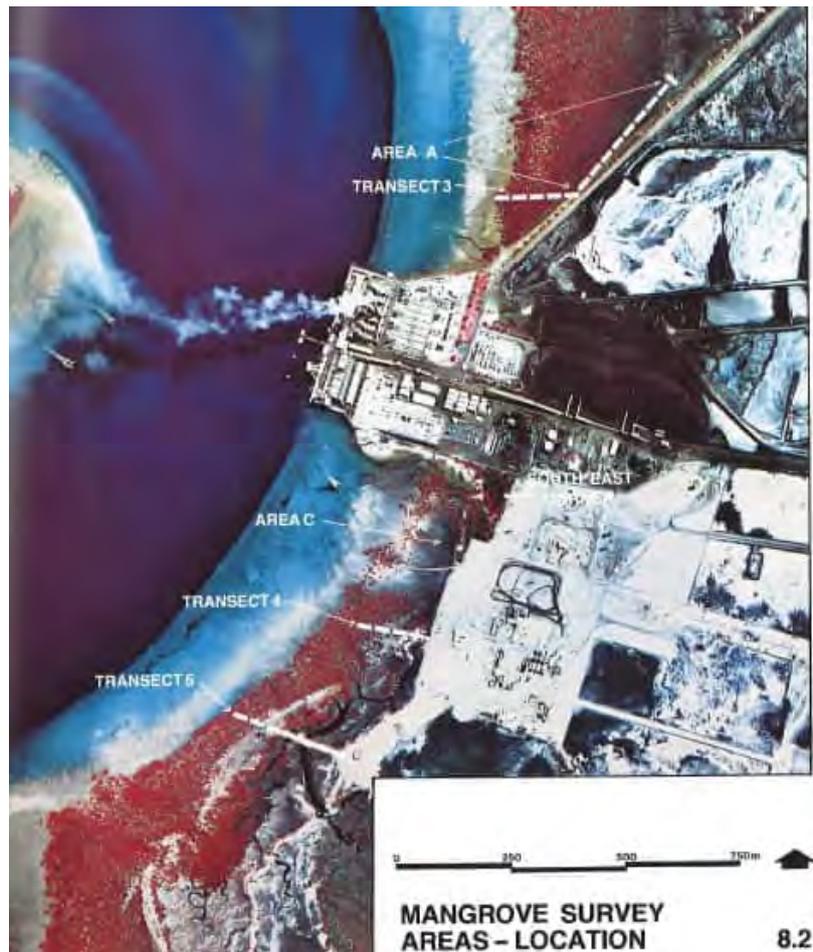
Figure 2.3: Mangrove areas surveyed (Kinhill Stearn, 1985)

Prior to the construction of the Northern Station, an Environmental Impact Statement was undertaken by Kinhill Stearn in 1985, with a supplementary statement provided in 1986 (Kinhill Stearn, 1985 and 1986). Within the assessment, mangrove health around the power station was discussed. Figure 2.3 shows the areas that had been surveyed and were the subject of the assessment:

Prior to 1961, it is recorded that the mangroves to the north (Area A) and south (Area C) of the Playford Stations had a number of die backs. It was determined that this was caused by sulphur dioxide emissions from the Playford chimneys (six short 40m high chimneys), these chimneys were replaced in 1961 by one 80m chimney (Kinhill Stearn, 1985). Aerial photographs reviewed between 1972 and 1984 showed a recovery and stabilisation of the mangrove community in these areas (Kinhill Stearn, 1986).

It was also noted that through the construction of the Northern Station including the cooling water channels, some areas of the mangroves, particularly Transect 4 and 5 and the southern area of Area C as shown in Figure 2.3 above were markedly changed by mechanical disruption (Kinhill Stearn, 1986) and as such, the mangrove community within this area has been highly modified.

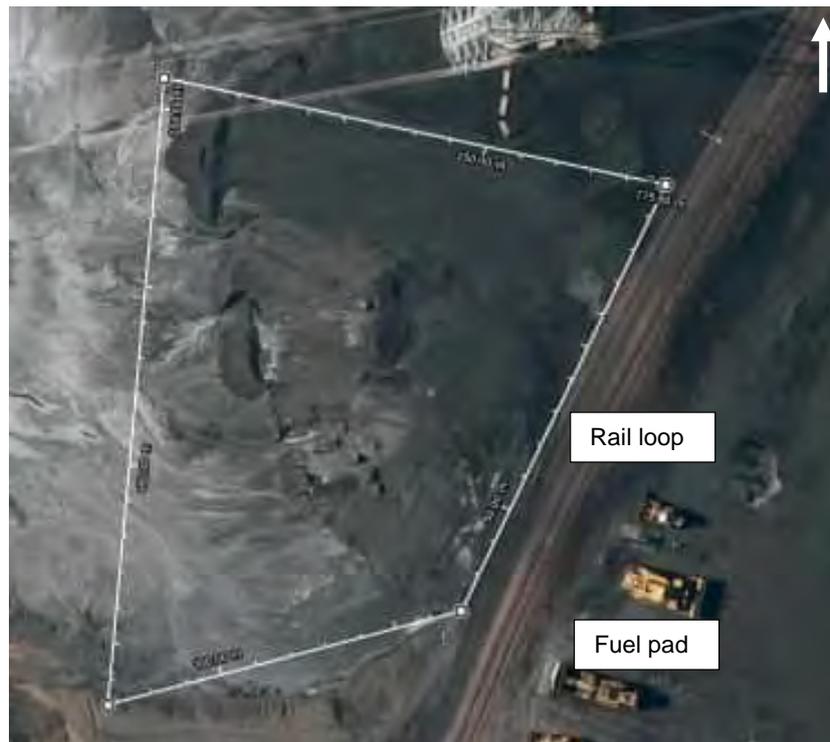
Unburnt coal that is remaining at the site comprises of coal rejects that could not be burned in the power generation process, unburnt coal removed from the coal conveyor including the bins and bunkers over time as well as the coal cleaned out of the coal conveyor bins during the site demolition works. The unburnt coal is deposited in the area as shown in Figure 2.4 below, east of the fuel pad and rail loop (Area 15) with an approximate volume, as of December 2016, estimated to be 5,200m³ (1.2m deep). There is approximately 200m³ of coal remaining within the coal conveyor bins to be added to this area. This area is noted to be included within the future management plan for the site and is currently intended to be revegetated.

Figure 2.4: Unburnt coal remaining (FPP)

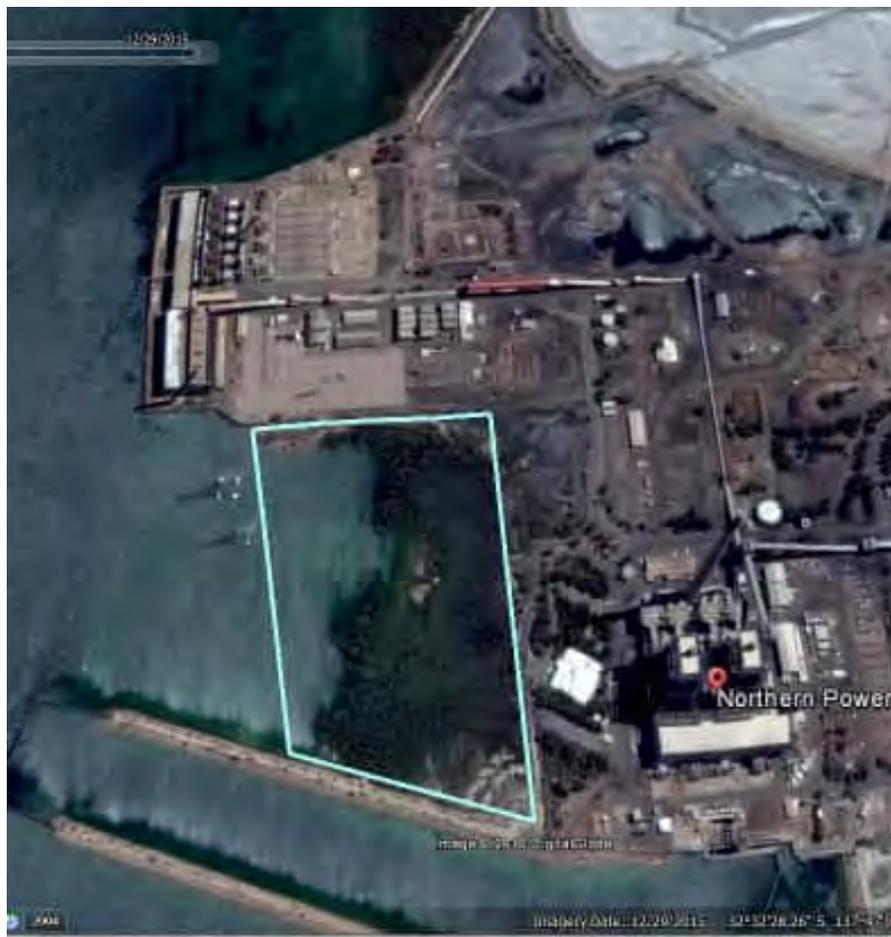
Figure 9.1: Mangrove swamp - area of investigation

The data collected has been used to undertake this Ecological Risk Assessment (ERA) to evaluate any potential ecological impacts of the discharge from the SPEL drains has had on the mangrove ecosystem located to the south of the Playford area between the Playford Stations and Northern Station. The mangrove ecosystem area under investigation ('the mangrove') is shown in Figure 9.1 below and presented in the overall site plan (Figure 8D).

The Playford area referred to herein includes the Playford Stations, switch yards, maintenance and workshop sheds and equipment laydown areas, all located north of the mangrove swamp. The Playford area investigations undertaken as part of this DSI, which provide the information for this ERA, include Area 1 (Playford A and B stations), Area 3 (Playford buildings), Area 5 (steel laydown area) and Area 6 (SPEL drain outlets).

Although there are mangroves present along the eastern side of the Northern Spencer Gulf in this region, both to the north and south of the site, the Mangrove Area that is the focus of this ERA is surrounded by the power plant facilities (see Figure 9.1):

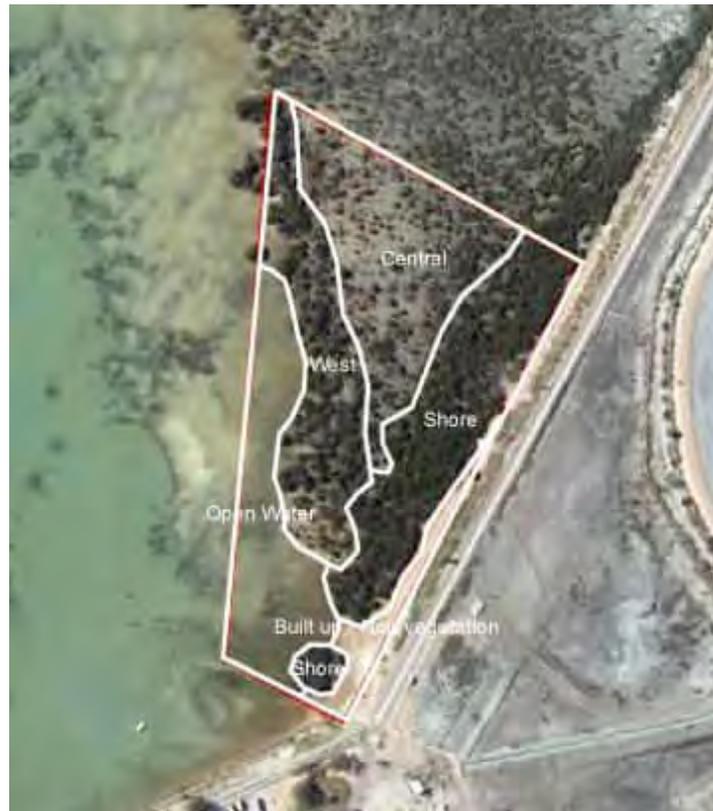
Figure 9.3: Vegetation condition mapping for the mangrove control site based on 2009 imagery (Ecological Associates, 2016)

The northern control site as shown in Figure 9.3 above, mangrove vegetation is in good condition, with the presence of barnacles and dense pneumatophores, and does not appear to show signs of environmental impact. The mangrove tree condition was generally considered to be moderate to very good. The canopy cover ranged from 75% shade in the Shore Zone to 20% in other areas where the tree density was less but the trees were generally in good health. Tree height was more than 2m in most trees however tree density across the zones was considered low, attributable to presence of largely mature trees.

It is noted this area of mangroves has suffered die backs on numerous occasions due to the sulphur dioxide emissions from the Playford chimneys in the 1950's as well as a 'slug' of highly saline groundwater migrating through these mangroves from the ash pond in the 1980's (Kinhill Stearn, 1986).
