SITE PLAN
Northern Battery Project

420 Northern Power Station Road
PORT PATERSON

for Davenport BESS Pty Ltd

Proposed Battery Energy Storage System

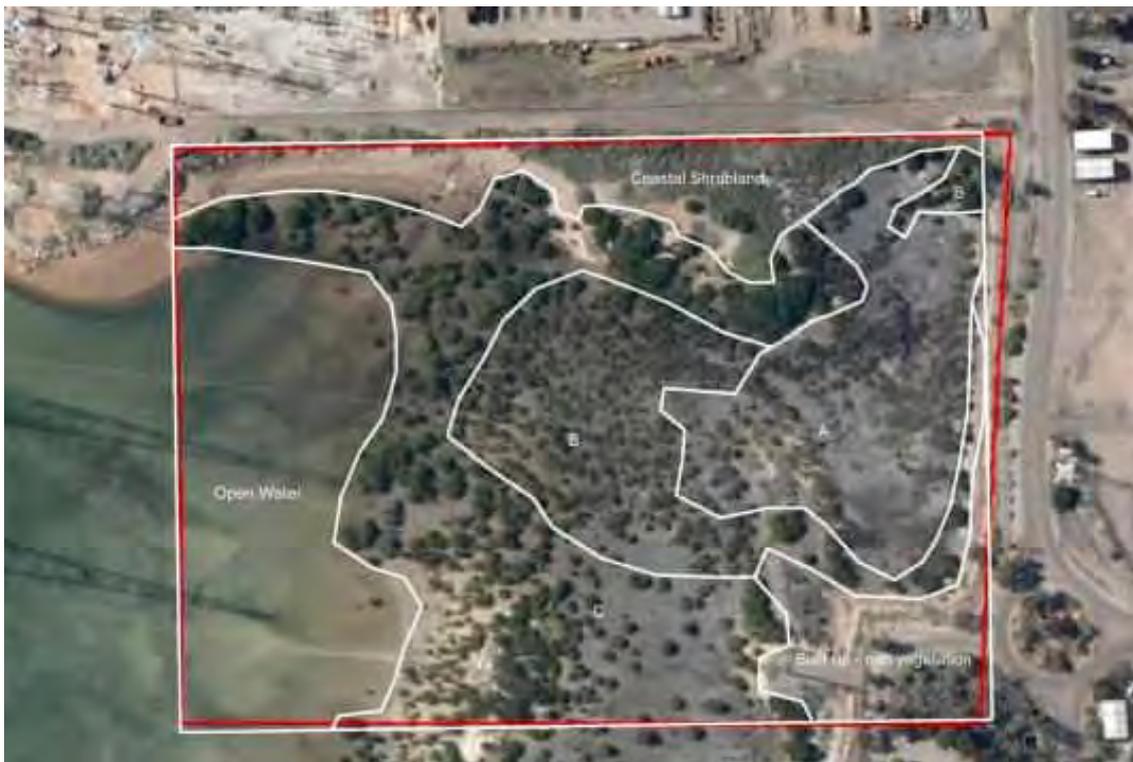
Figure 9.4. Vegetation condition mapping for the mangroves based on 2009 imagery (Ecological Associates, 2016)

The mangrove under ERA as shown in Figure 9.4 above, was observed to be in poorer condition. For the purposes of this assessment the investigation area has been divided into three zones on the basis of vegetation mapping. Refer to Figure 9.4 for the location and extent of the designated zones. Tree condition in Zone C, located in the deepest waters, were in good condition however Zone B trees in the central area of the mangroves were mainly moderate or good condition with a significant portion in poor condition. Trees in Zone A were mostly dead. Zone A generally includes the discharge area related to SPEL 1 and the eastern portion of the mangrove. Canopy coverage ranged from 20-30% in Zones B and C due to low tree density and <1% in Zone A. Tree height in Zone A was mostly <1m and included dead seedlings and stumps of dead immature trees. Zone B also contained a large number of trees < 1m, including many juvenile trees. The majority of trees in Zone C were 2-3m tall. Tree density in Zone C was low however Zone A and B were considered high due to the high numbers of seedlings and immature trees in Zone B.

While the flora and fauna assessment indicated that degradation of this area appears to have occurred between 2002 and 2009, historical aerial photography between the 1950's and 2016 does not support this and indicates the area has recovered from the 1950's dieback, and stabilised following the Northern Station construction disruption. This area has also had a number of replanting events.

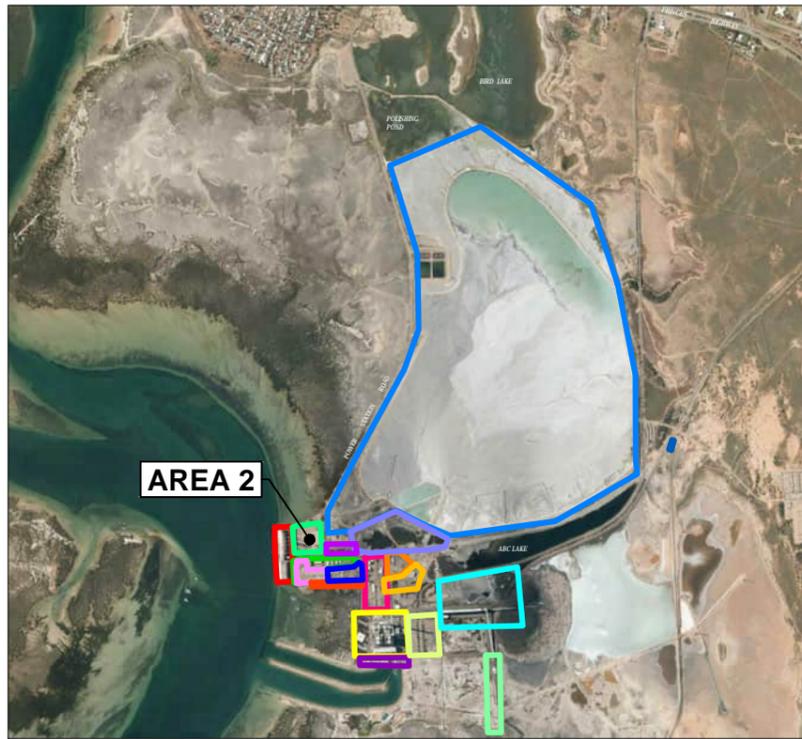
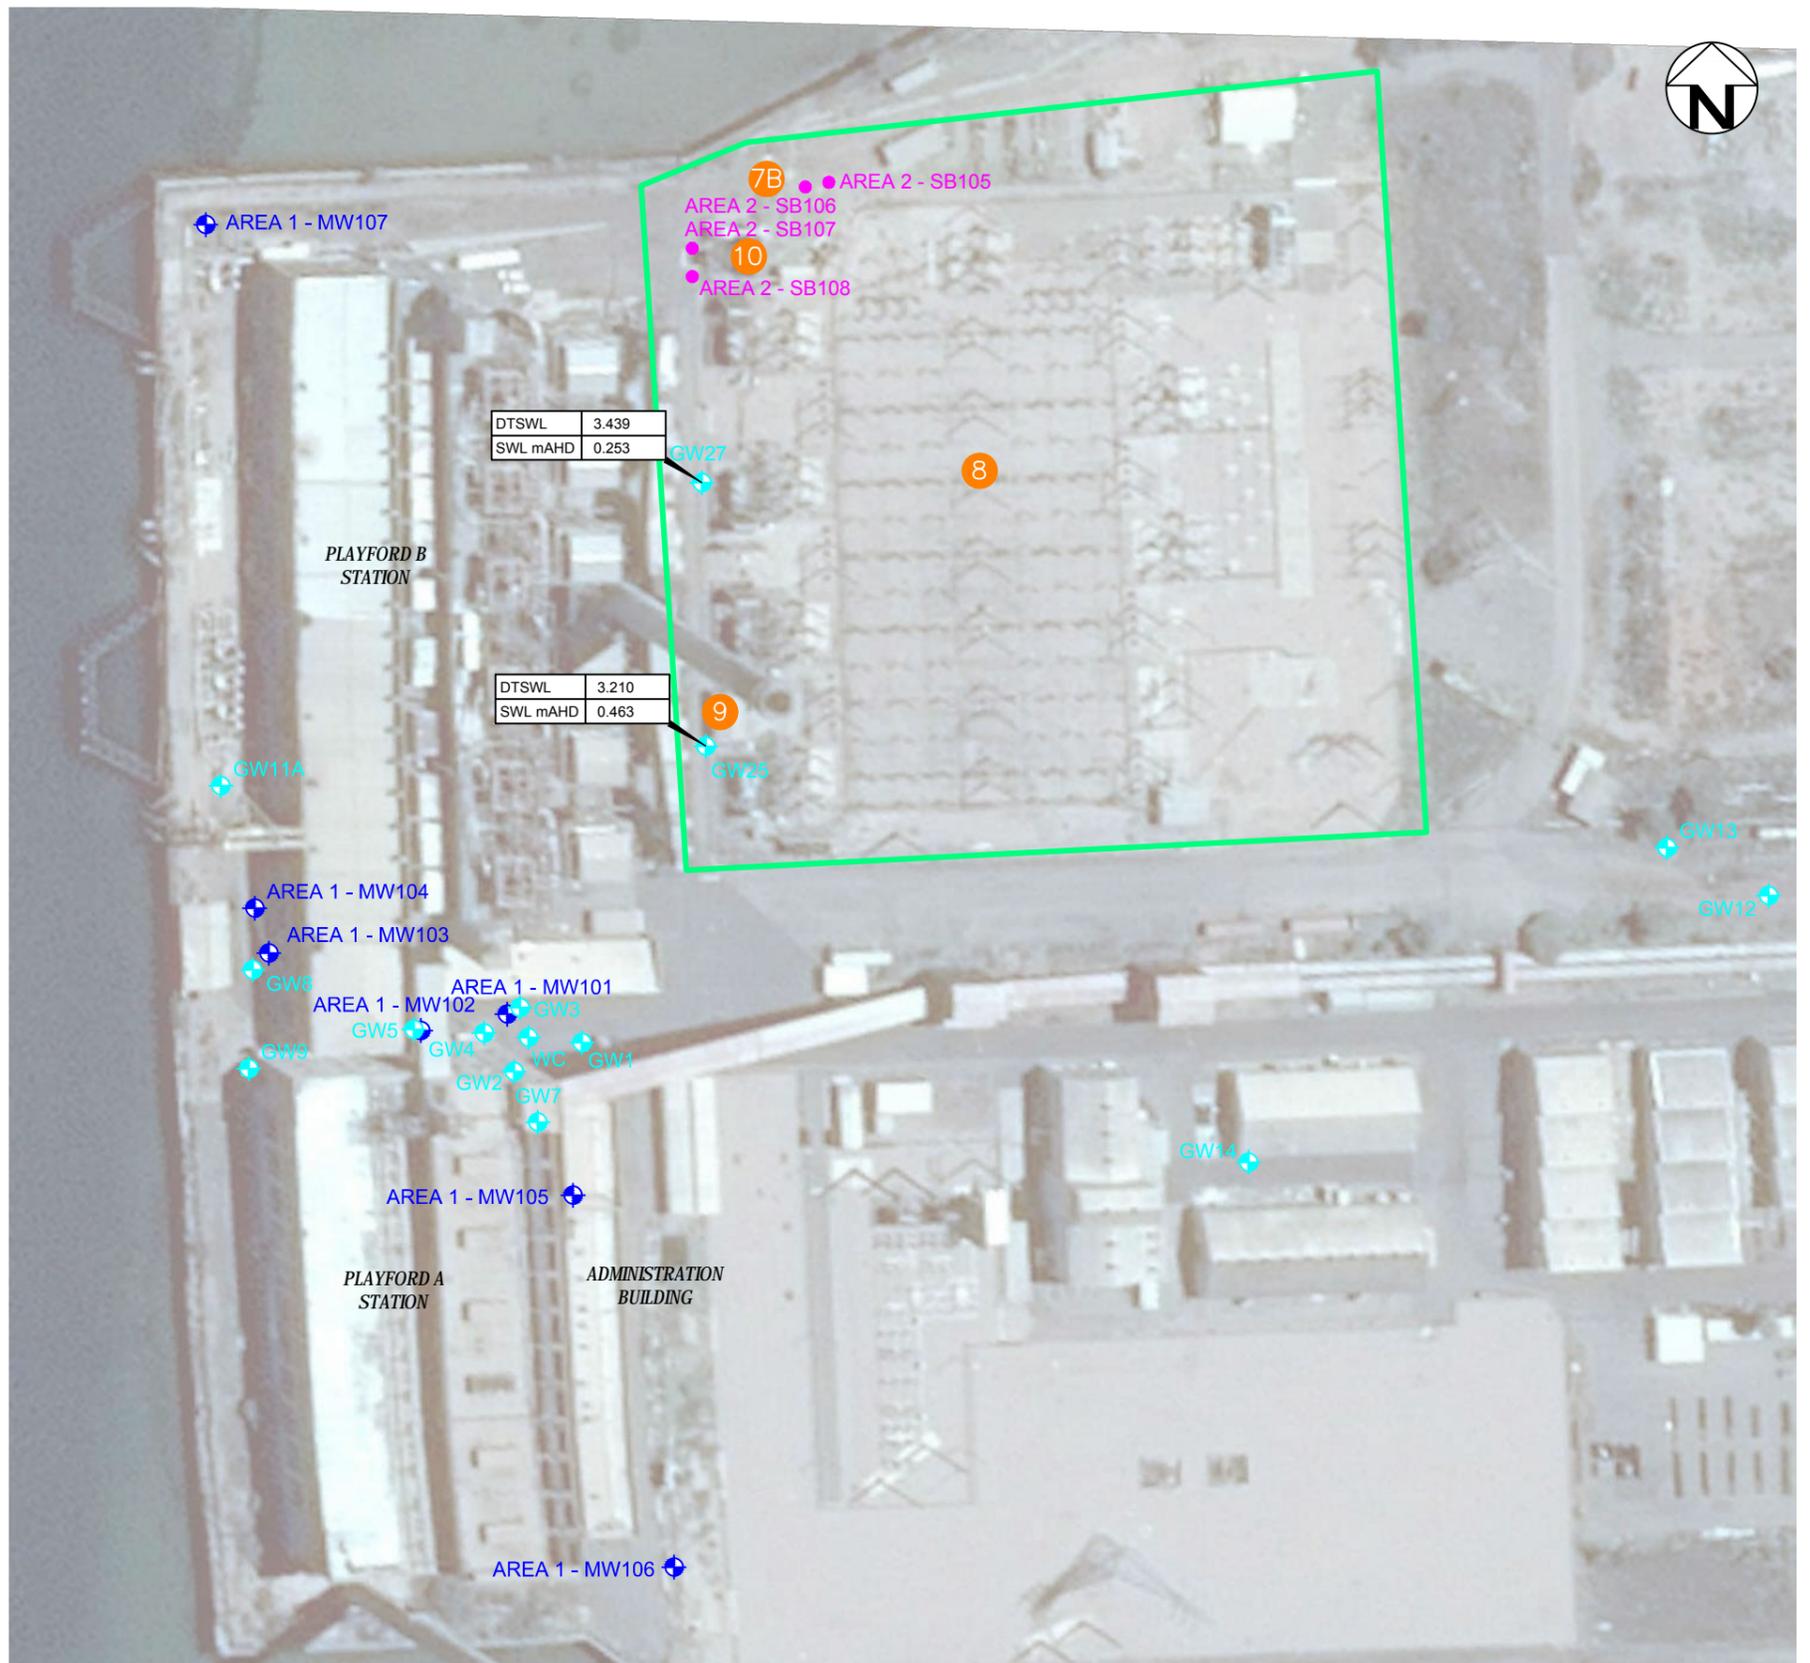
client:	FLINDERS POWER PARTNERSHIP		
project:	FLINDERS POWER PARTNERSHIP AUGUSTA POWER STATIONS DSI POWER STATION ROAD, PORT AUGUSTA, SOUTH AUSTRALIA		
title:	AREA 2 - PLAYFORD B SWITCH YARD (MAY-JULY 2016)		
project no:	ENAUKEW01445AD-R01-D01	figure no:	FIGURE 4
rev:	B

- APPROXIMATE GROUNDWATER BORE LOCATION (EXISTING)
 - NEW GROUNDWATER BORE LOCATION
 - SOIL BORE LOCATION
 - AEC SPEL DRAIN
 - AEC PLAYFORD B SWITCH YARD
 - AEC COAL / ASH WORKSHOP
 - AEC ASH POND SUMP
 - DTSWL GAUGED DEPTH TO WATER (METRES)
 - SWL mAHD GROUNDWATER ELEVATION (mAHD)
- NOTE: SOIL AND GROUNDWATER ANALYTICAL RESULTS FROM AREA 2 ARE REPORTED BELOW BACKGROUND LEVELS

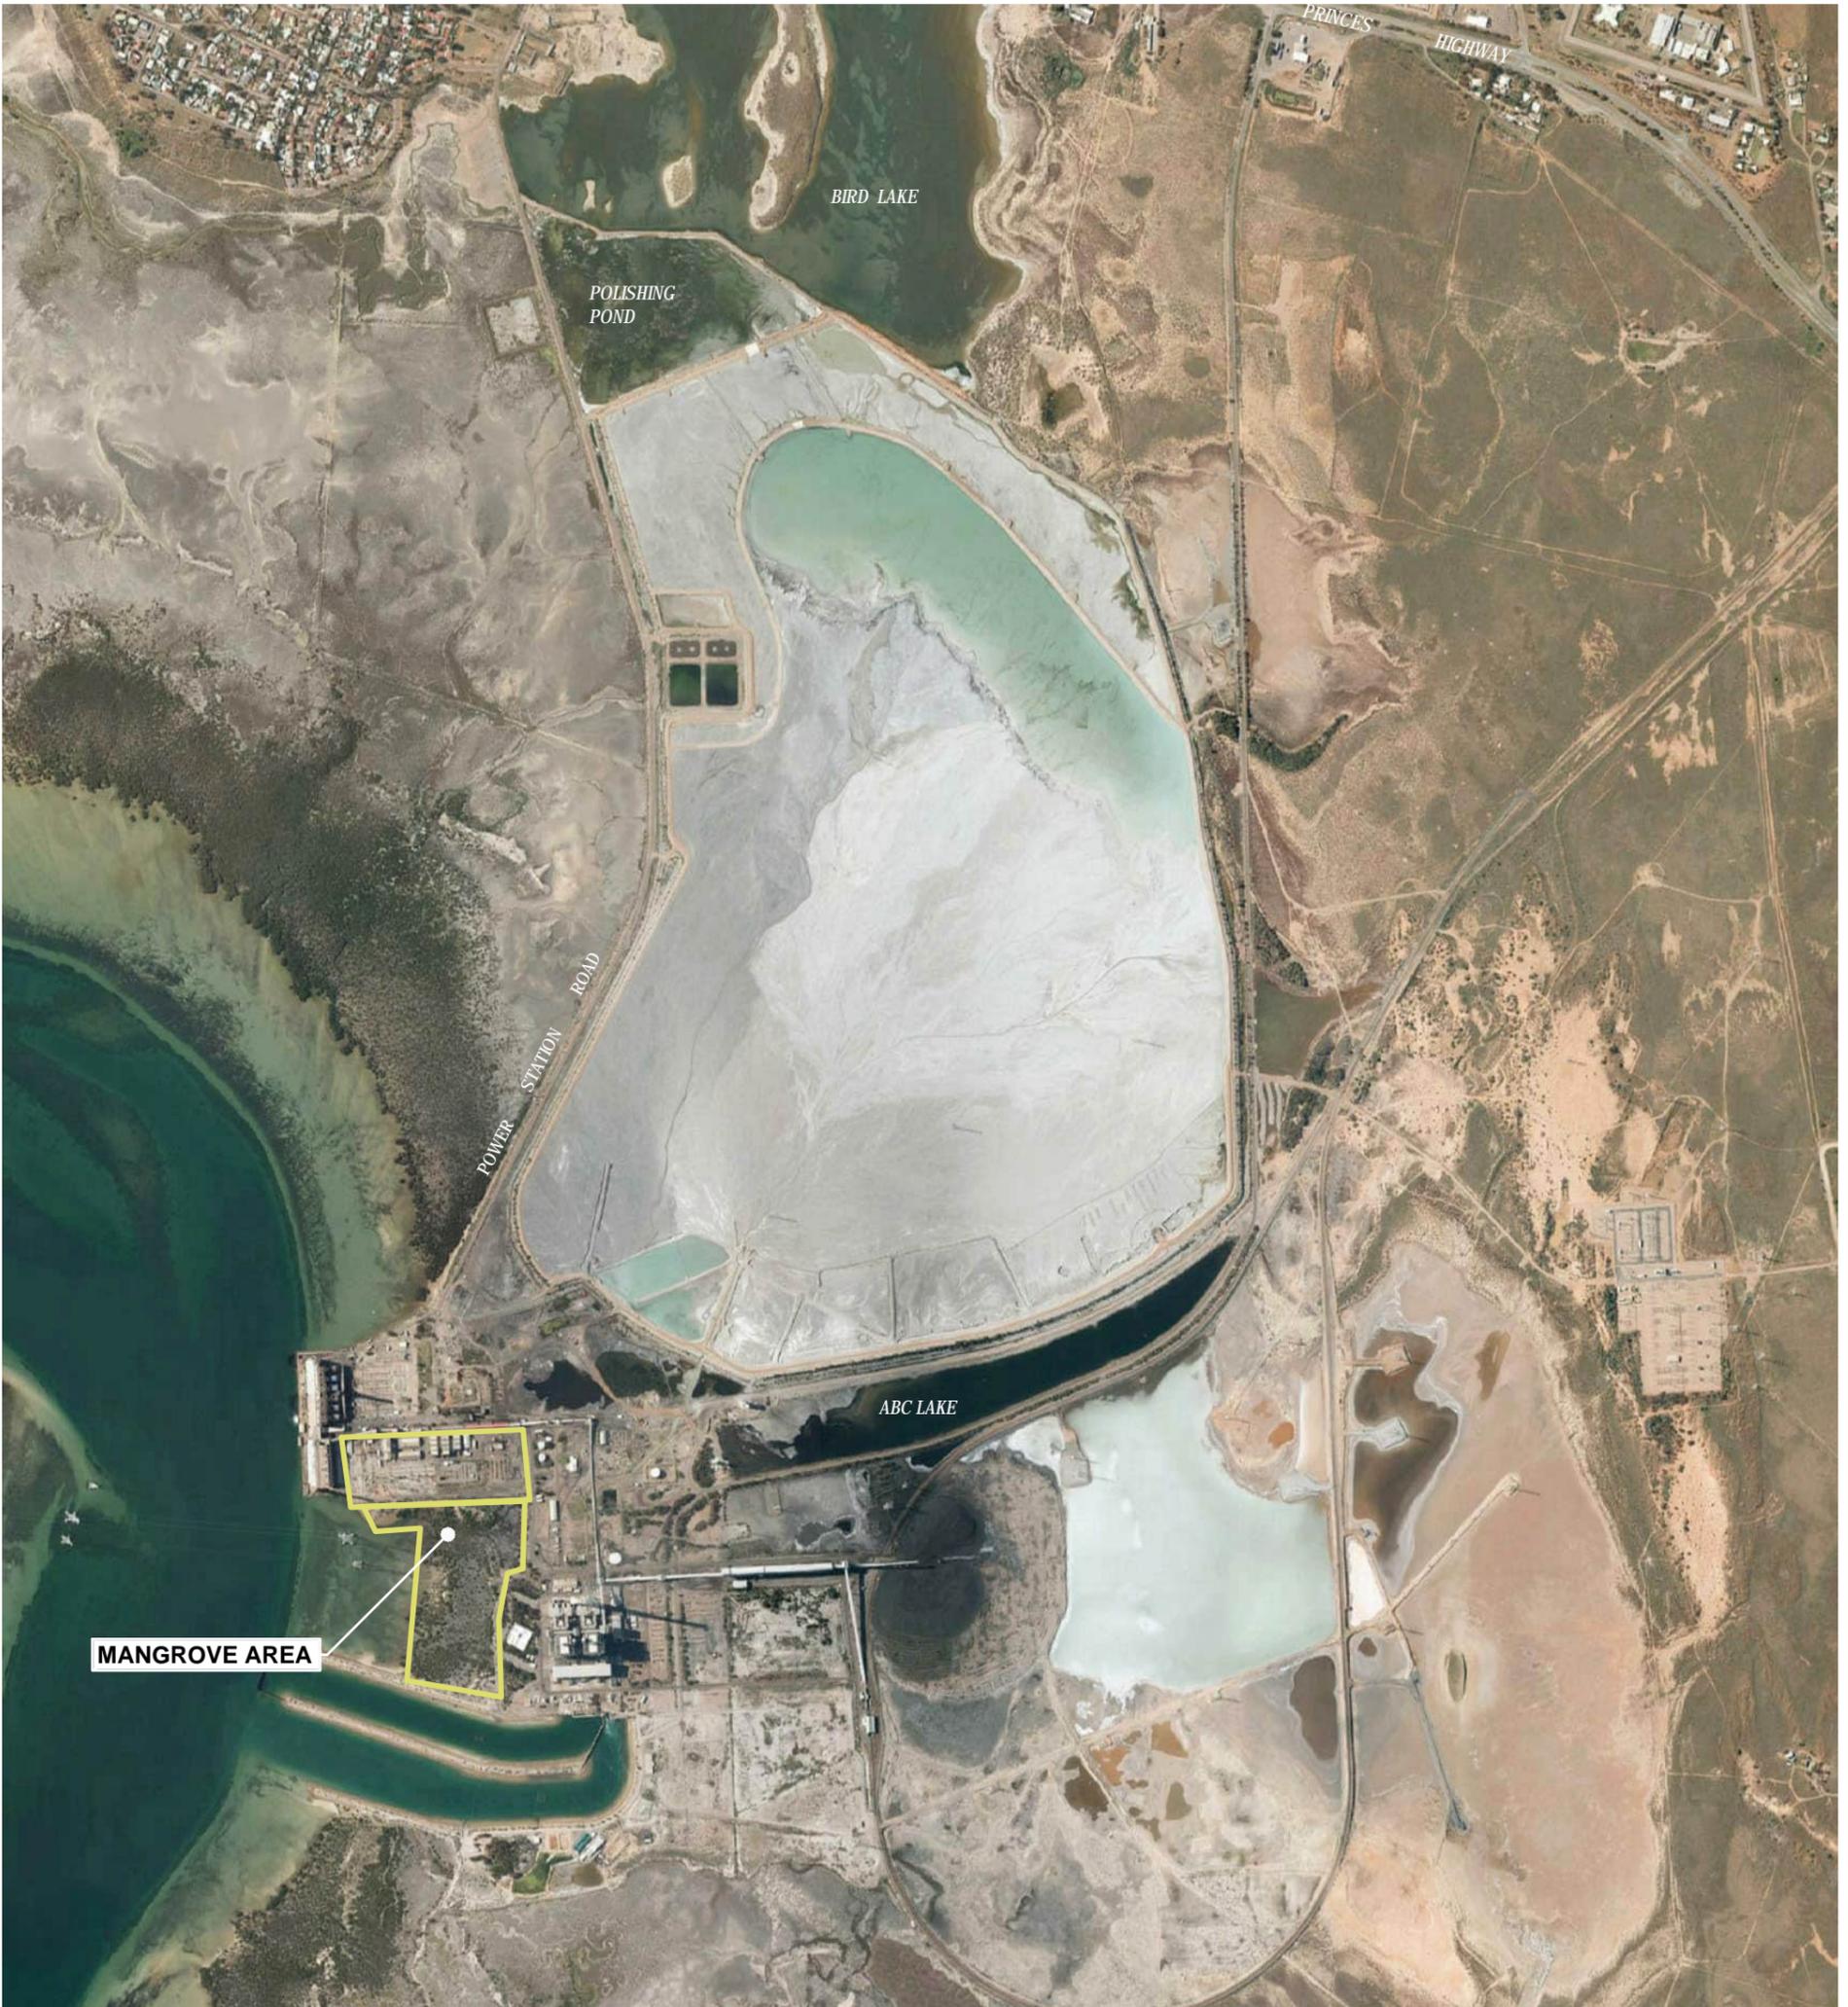
client:	FLINDERS POWER PARTNERSHIP		
project:	FLINDERS POWER PARTNERSHIP AUGUSTA POWER STATIONS DSI POWER STATION ROAD, PORT AUGUSTA, SOUTH AUSTRALIA		
title:	MANGROVE AREA OF INVESTIGATION		
project no:	ENAUKEW01445AD-R01-D01	figure no:	FIGURE 8D
		rev:	B

The extent of impacts in sediments beyond the area sampled is not known. Background samples collected from the southern extent of the mangrove (BS1 & BS2) suggest the impact is potentially concentrated in the north. The flora and fauna report found the poorest habitat at the mangrove (Zone A) extends approximately 130m south and south west of SPEL 1 (refer to Figure 9:4 above in Section 9.4.1 for Zone A extents).

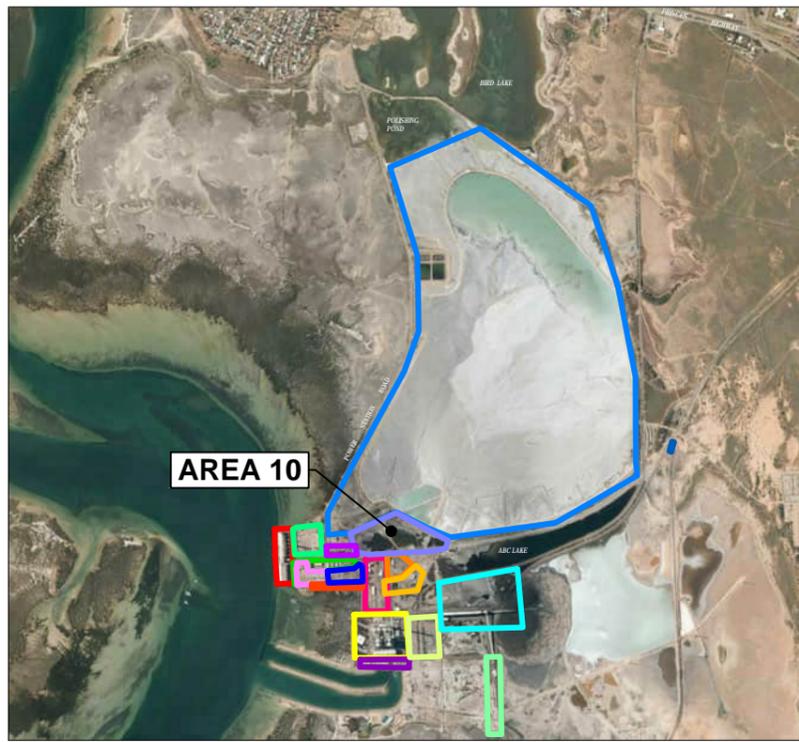
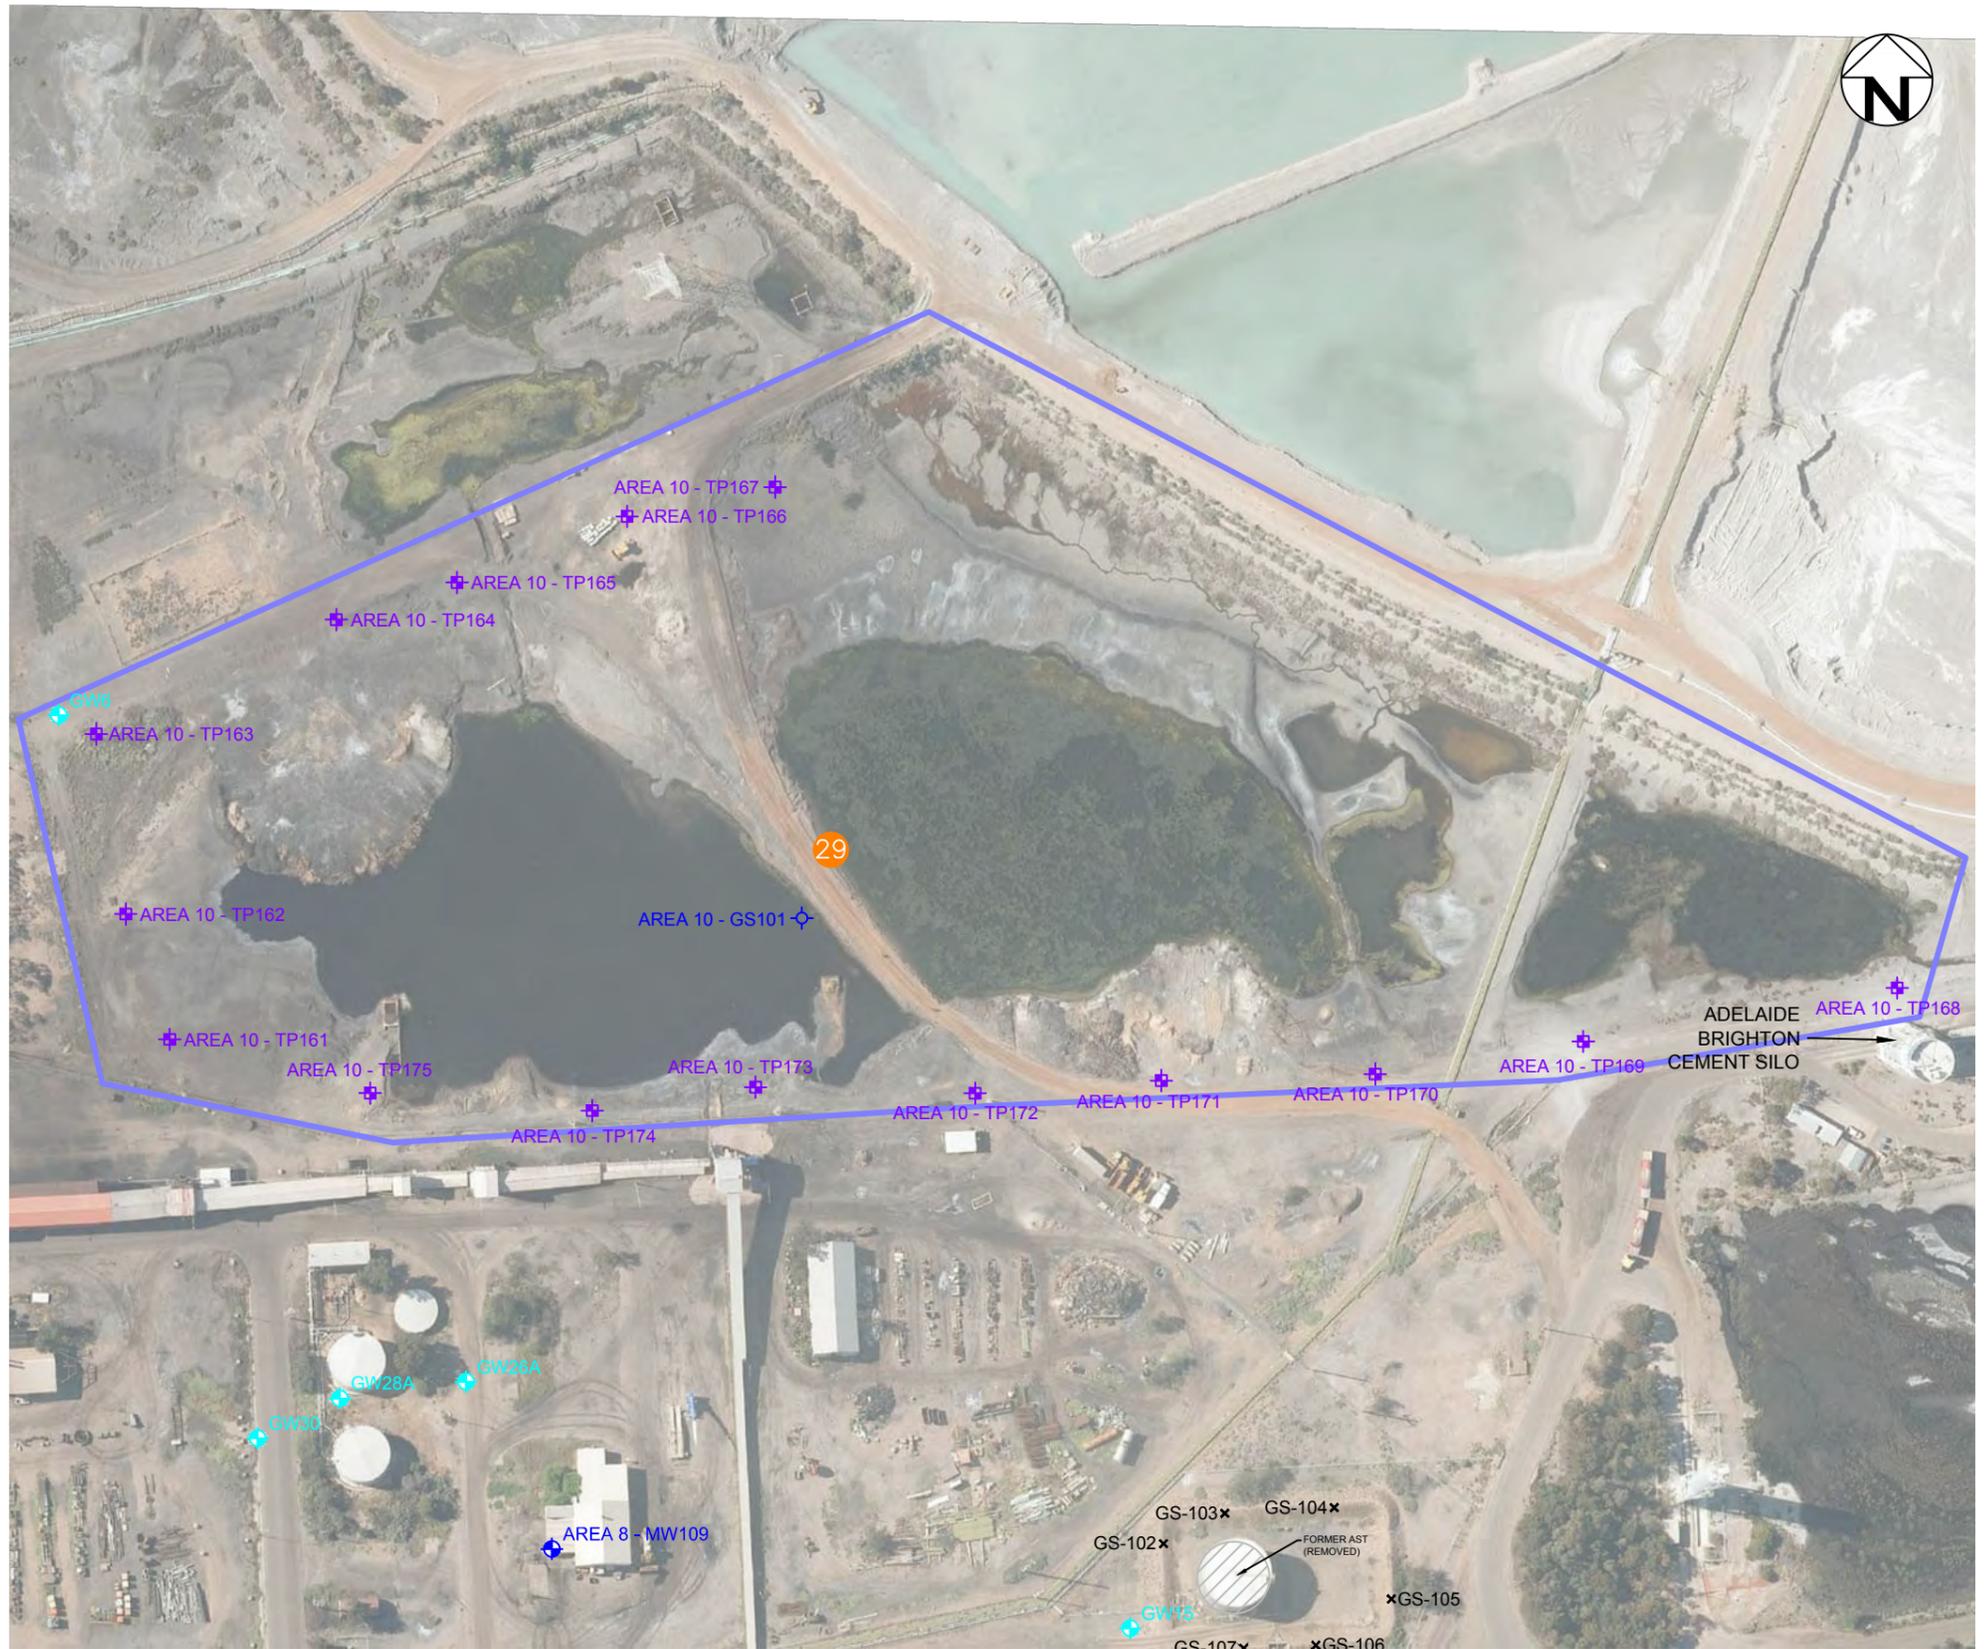
client:	FLINDERS POWER PARTNERSHIP		
project:	FLINDERS POWER PARTNERSHIP AUGUSTA POWER STATIONS DSI POWER STATION ROAD, PORT AUGUSTA, SOUTH AUSTRALIA		
title:	AREA 10 - FORMER COAL LOADING AREA AND STOCKPILES (MAY - JULY 2016)		
project no:	ENAUKE\SW01445AD-R01-D01	figure no:	FIGURE 12A
rev:	B

Area 10 – Former Coal Loading Area (Table 12A, Figure 12B)		
AEC 29	Area10-TP161 0.4-0.5mbgs	Minor concentrations of TRH >C ₁₆ -C ₃₄ .
	Area10-TP166 0.3-0.4mbgs	
	Area10-TP167 0.4-0.5mbgs	
	Area10-TP172 0.4-0.5mbgs	
	Area10-TP175 0.4-0.5mbgs	
	Area10-TP170 0.1-0.2mbgs	Minor concentrations of TRH >C ₁₆ -C ₃₄ and TRH >C ₃₄ -C ₄₀ .
Area 11 – Wastewater, Fuel Storage and Washdown Area (Tables 13A & 13B, Figure 13B)		
AEC 31A	Area11-TP184 0.4-0.5mbgs.	Minor concentrations of TRH >C ₁₆ -C ₃₄ .
AEC 31B	Area11-MW114 2.4-2.7mbgs	Minor concentrations of TRH >C ₁₆ -C ₃₄ .

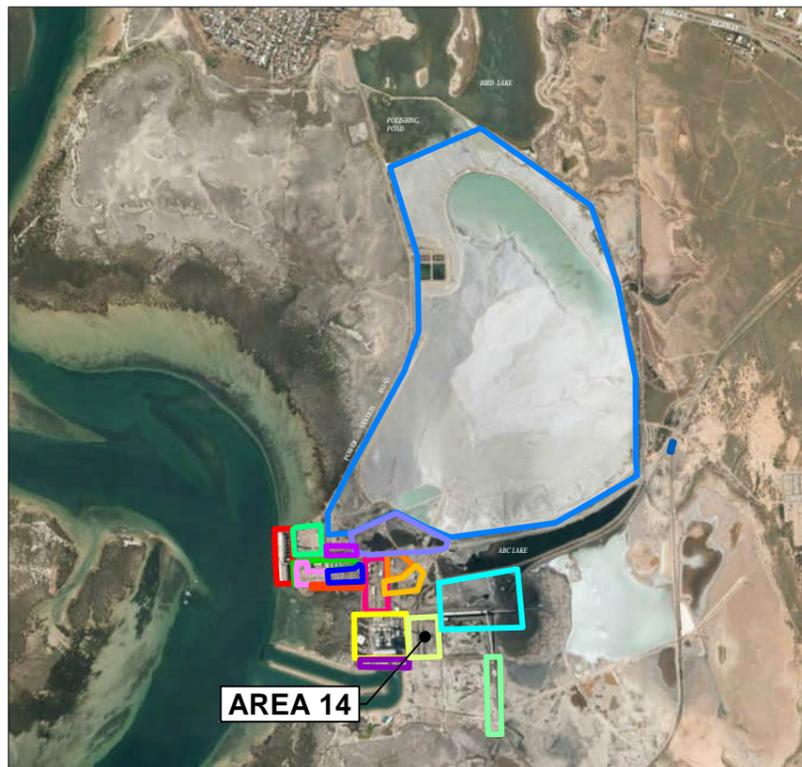
client:	FLINDERS POWER PARTNERSHIP		
project:	FLINDERS POWER PARTNERSHIP AUGUSTA POWER STATIONS DSI POWER STATION ROAD, PORT AUGUSTA, SOUTH AUSTRALIA		
title:	AREA 14 - STEEL LAYDOWN AREA (MAY-JULY 2016)		
project no:	ENAUKEW01445AD-R01-D01	figure no:	FIGURE 16A
			rev: B

- A test pit (Area14-TP203) was undertaken in the area of the former waste dump (AEC 51C) located in the steel laydown area (Area 14, Figure 16A). The test pit confirmed that the waste in this area had previously been excavated and backfilled with fill material.

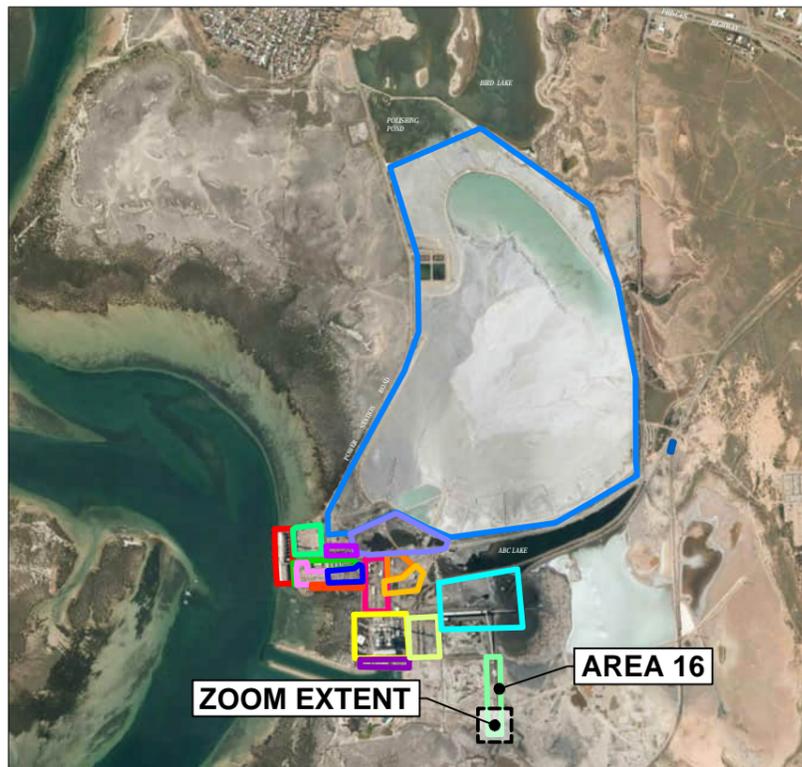
client:	FLINDERS POWER PARTNERSHIP		
project:	FLINDERS POWER PARTNERSHIP AUGUSTA POWER STATIONS DSI POWER STATION ROAD, PORT AUGUSTA, SOUTH AUSTRALIA		
title:	AREA 16 - TRAIN UNLOADING AREA (MAY-JULY 2016)		
project no:	ENAUKEW01445AD-R01-D01	figure no:	FIGURE 18A
			rev: B

49A & 49B Wash down of carriages	To assess the wash down practices, nine shallow test pits were excavated along the soil swale alignment.	Area16-TP244 to Area16-TP253 were excavated to a depth of 0.1mbgs.
51A & 51B Waste dumps, SMF/asbestos and general waste	To determine the extent and nature of the waste dump, test pitting was undertaken across the area.	Refer Figure 18B. No soil sampling was required, visual assessment only.
Area 17 – Ash pond (Figure 19A)		
50A Ash pond	Groundwater monitoring of the selected existing wells to understand the groundwater conditions.	APS-1, APS-5, APS-7, APS-23 and APS-30 to APS-37.
50B Waste water system Ash pond Stage 2 pumps	To determine if any leaks have occurred over time from the ash pond stage 2 pumps, two test pits were excavated.	Area17-TP254 and Area17-TP255 were excavated to a depth of 0.5mbgs.
51F Waste dump, general waste	To determine the extent and nature of the waste dump, test pitting was undertaken across the area.	Refer Figure 19B. No soil sampling was required, visual assessment only

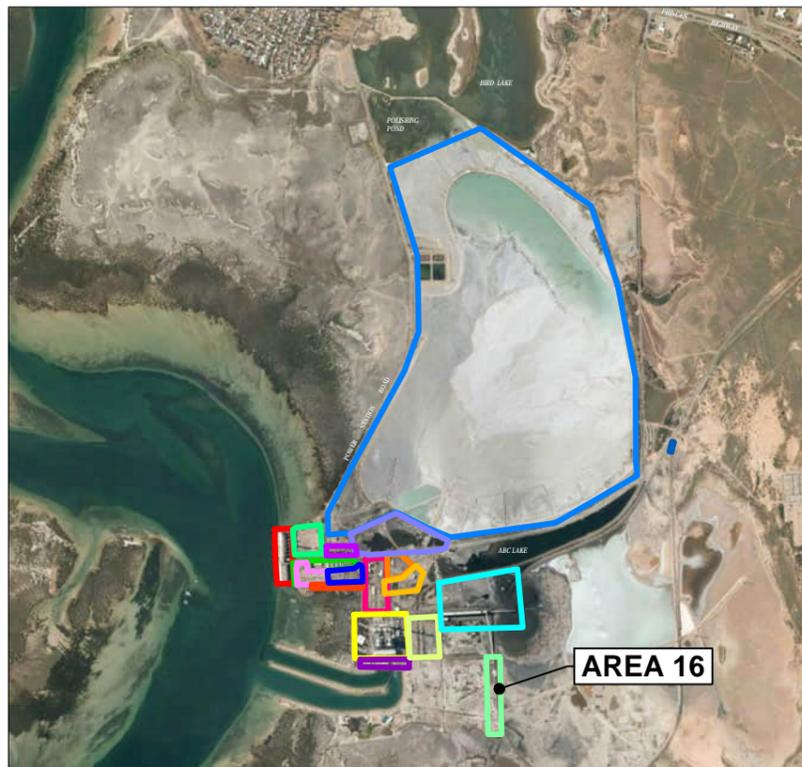
- A series of trenches were undertaken across the area of AEC 51A SMF dump and AEC 51B general waste dump located to the south of the train unloading area (refer Figure 18B). The works identified general waste and SMF waste buried in the area with the maximum vertical extent noted at 3mbgs. No asbestos containing material was encountered within this dump.
